## **Praxis-Kalibrierung der neuen mobilen Grossversuchsanlage MLS10 für be- schleunigte Verkehrslastsimulation auf Strassenbelägen in der Schweiz**

**Performance-Calibration of the novel full-scale test ma-  
chine MLS10 for accelerated traffic simulation on Swiss  
roads**

**Empa, Eidgenössische Materialprüfungs- und Forschungsanstalt**  
**Martin Arraigada, Dr., dipl. Ing.**  
**Manfred N. Partl, Prof. Dr., dipl. Ing. ETH**  
**Hiroyuki Kato, dipl. Ing.**  
**Andrés Pugliesi, dipl. Ing.**  
**Andreas Treuholz, Msc.**

**Forschungsauftrag ASTRA 2007/011 und ASTRA 2010/005\_OBF auf  
Antrag des Bundesamtes für Strassen (ASTRA)**

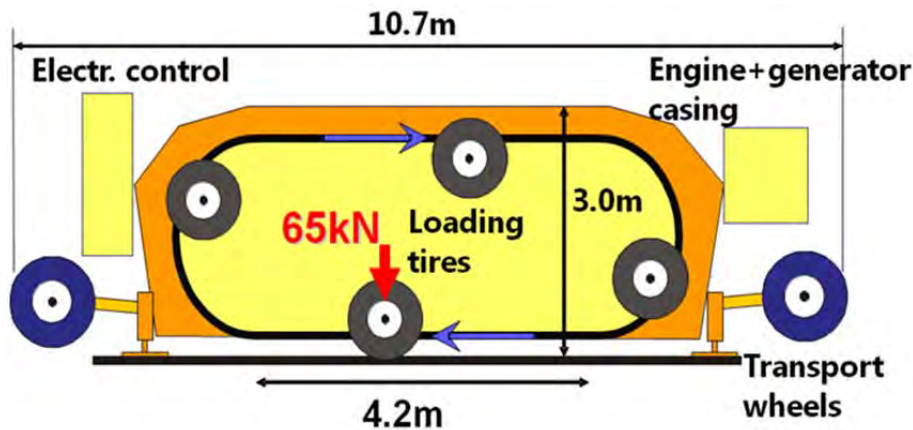
The tires for loading the pavement are mounted in bogies, which are strong steel framed carriages that are coupled to a kind of chain rolling along the guide rails. The 4 bogies of the MLS10 have steel wheels that fit within the rails. The bogies are pulled contactlessly by 24 linear induction motors (LIM). The rails are built in such a way that the freely revolving tires touch down smoothly to the surface before loading the pavement over the trafficked path length. A schema of the loading system is depicted in Fig. 2.2.

Fig. 2.2 Schema of the loading principle

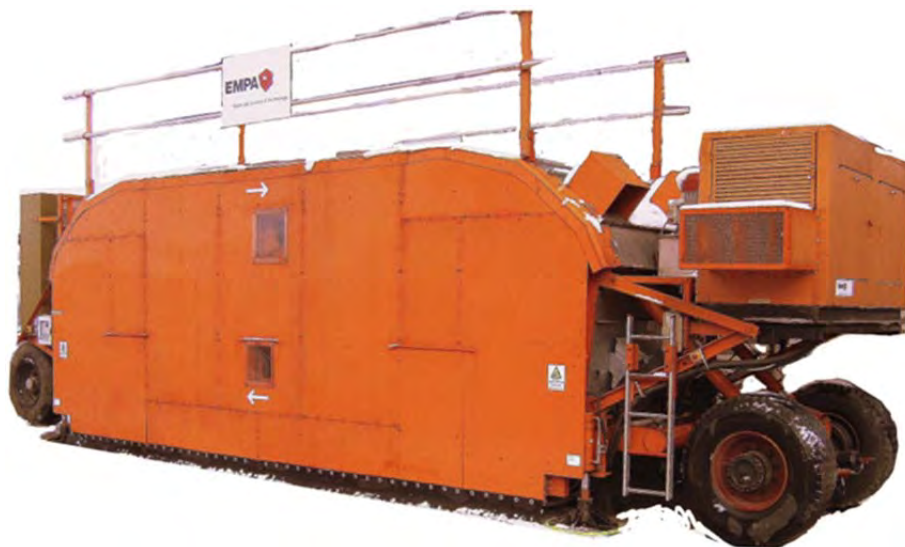
The frame is enclosed by a noise reduction cover, confining all moving. In order to monitor the loading during trafficking, the dynamic movements of the suspension system are registered electronically and transferred via Bluetooth to a computer. The MLS10 is equipped with four transport wheels which can be raised and lowered hydraulically, thus lifting up the whole frame by about 1m and giving room for maintenance work, such as checking tire pressures and pavement sensors, as well as measurements of profiles, crack and damage inspection or measurements with more elaborated devices, such as the portable seismic pavement analyzer PSPA or ground penetrating radar GPR. The transport wheels allow the maneuvering of the machine around the test site and to drive it to or off low bed trucks for long distance transport. The possibility of easily driving the MLS10 on a flatbed truck makes it fully mobile. The MLS10 has a generator for fully autonomous powering of the machine. A bulk view of the MLS10 is presented in Fig. 2.3.

Fig. 2.3 View of the MLS10

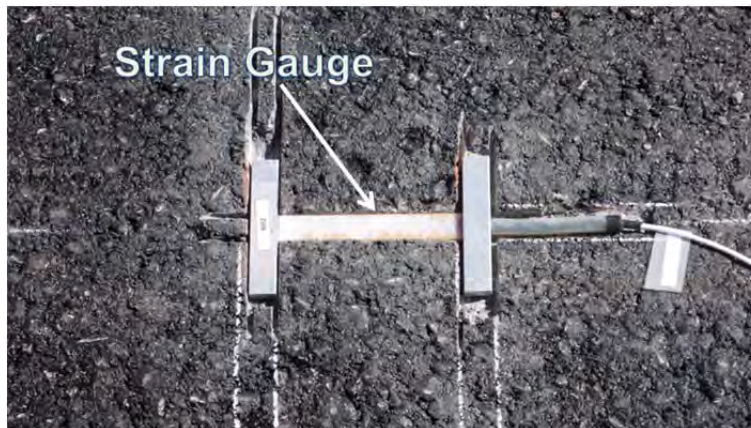
the hot mix asphalt during compaction (see Fig. 5.3). After finishing the compaction of the layers, the dummies were taken out and the sensors were placed in the trench.

Fig. 5.3 Strain gauges, installation in the pavement

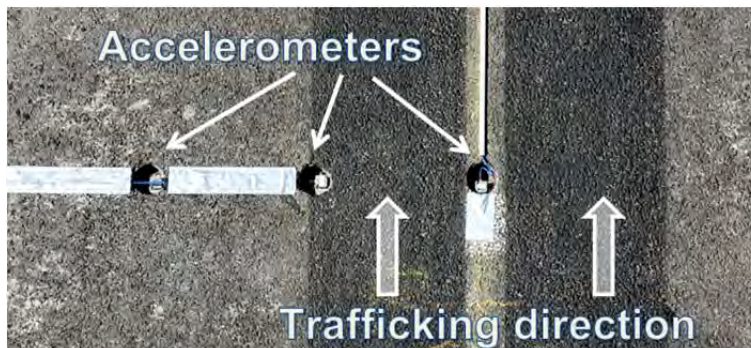
- **Accelerometers:** In order to obtain the dynamic deflection of the pavement under the MLS10, 3 accelerometers were installed in a line perpendicular to the trafficking direction. The mounting was done by drilling holes of 5cm diameter down to a depth of 3cm (see Fig. 5.4). The accelerometers were screwed to plates firmly attached to the bottom of the hole. The sensors selected for this work were the capacitive accelerometers model 3700 from PCB. These accelerometers are rugged and were specially prepared with integrated water proof cabling to withstand extreme climatic conditions. Data acquisition was done simultaneously with the strain gauges and stored for post-processing analysis. More information about the data analysis and interpretation can be found elsewhere [13] [14].

Fig. 5.4 Installation of the accelerometers

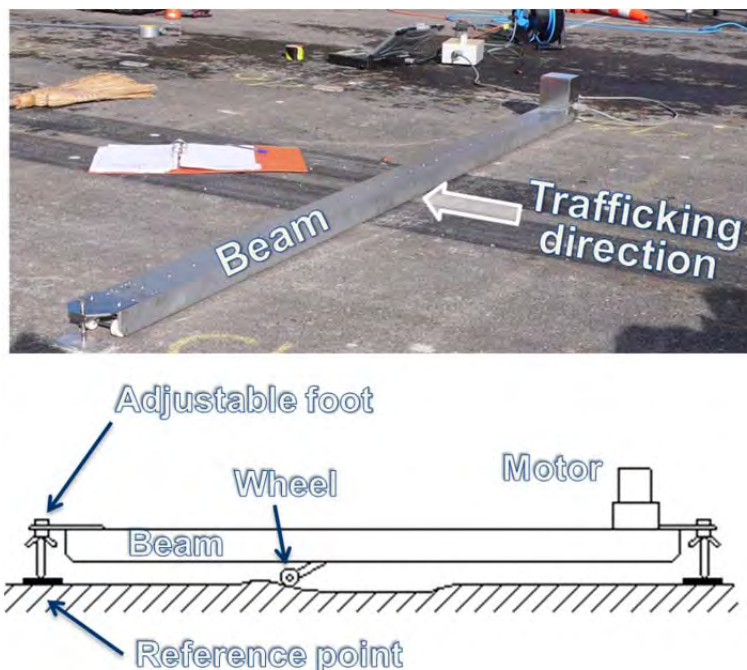
- Transversal profiles: Permanent deformation of the pavement surface was calculated by analysing three profile measurements for each section, all perpendicular to the trafficking direction. Measurements were carried out with the MLS profiler. The profiler consists of a steel beam which has a wheel on the bottom side (see Fig. 5.5). For each measurement, the beam is fixed to two steel plates that are glued to the pavement surface, outside the trafficked area which serve as “reference points”. The beam distance to pavement can be set with a pair of adjustable feet at each end of the beam. This setup provides a stable frame for the measurements. A moving wheel situated in the bottom part of the beam travels in contact to the surface of the pavement, following any unevenness up to 1mm. The combination of vertical and horizontal movement allows drawing the profile, which is expected to change throughout the tests due to permanent deformation. Consequently, measurements were taken recurrently after a regular number of load applications in order to follow the increase of rutting versus the accumulated number of loads.

Fig. 5.5 View of the profiler used for rutting measurements

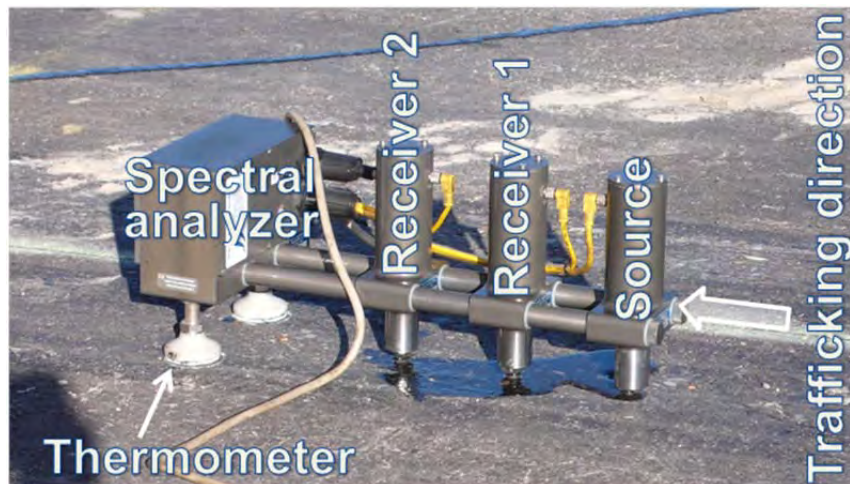
- Portable Seismic Pavement Analyser (PSPA): Monitoring of seismic stiffness of the pavement layers was conducted with the PSPA. The device uses the theory of wave propagation in continuous media to determine the seismic modulus of each layer. Literature describing the theory about PSPA stiffness calculations can be found in [10], [11] und [12]. The PSPA is composed of two ultrasonic receivers, one source and one spectral analyser that sample the analogous electric signal coming from the receivers into numerical data. The distance between the source and both receivers is fixed and defines the setup. The device is equipped with a thermometer in one foot, in direct contact with the pavement surface. Measured values are used later for temperature normalization. A picture of the device is presented in Fig. 5.6. For this APT three measurements per test section, two in each of the wheel paths and one outside the trafficking zone, were carried out.

Fig. 5.6 View of the PSPA in measuring position

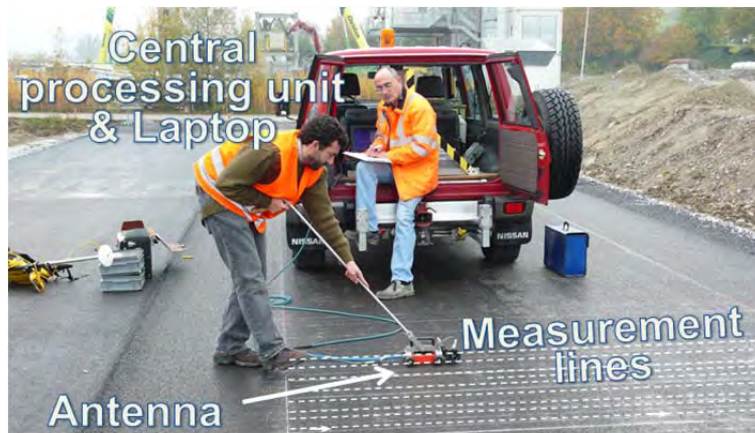
- **Ground Penetrating Radar (GPR):** This is a non-destructive testing device that uses electromagnetic waves to determine the geometry of a structure. The working principle is based on the measurement of the change of the dielectric permeability of the different materials. The device consists of an antenna that radiates an electromagnetic signal to the subsurface, which is reflected in every interface between layers. The same antenna collects the reflection of the signal, which is processed by the central unit and stored in a laptop for later post processing. Radar data is collected along parallel lines (see Fig. 5.9) as a series of single measurement tracks. When single track measurements are plotted next to each other, the result is an image that will show the properties of the subsurface. Such a representation is called radar profile and the resolution and depth depends on the size of antenna. Antennas that produce high frequency signals have higher resolution (can detect changes in dielectrical permeability in small areas), but only near the surface, whereas lower frequency antennas go deeper in the inspection, but the resolution is poor, compared to the first ones.

Fig. 5.9 Inspection of the pavement with GPR.

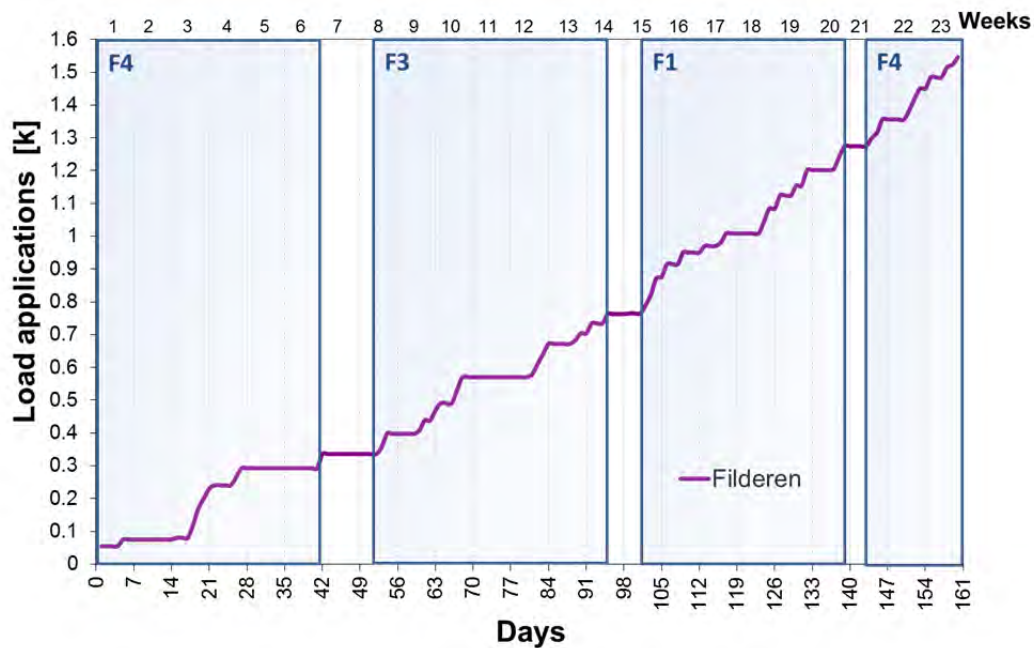
The MLS10 was deployed to the testing site during two seasons. The first operation period started 12<sup>th</sup> of November 2008 and finished on 5<sup>th</sup> of November 2009. Due to a crack in one of the bogies the machine was sent back for refurbishing during winter break. Newly designed bogies were installed and the MLS10 was operational again shortly after winter. The 28<sup>th</sup> of May 2009 the tests were continued until 4<sup>th</sup> of November 2009. In total, 1'605'928 loads were applied to the three different pavements of Sections F1, F2 and F4 throughout a total of 161 days. The machine was regularly displaced on the testing site to have, on average, the same temperature profile in each section. The accumulated number of loads through the duration of the tests is presented as a line in Fig. 5.19. Horizontal segments in the line represent the days where the MLS10 was not operational due to holidays, weekends, breakdowns, measurements, installation of sensors, etc. The problems and actions done to improve the performance of the machine during this period are described in the next section. The line shows that, at the beginning of the tests, the performance of the machine was poor because of prolonged breakdowns and repairing times. In the second half of the testing period, the performance increased, due to a clear reduction of the breakdowns.

Fig. 5.19 Number of MLS10 accumulated load applications vs. time

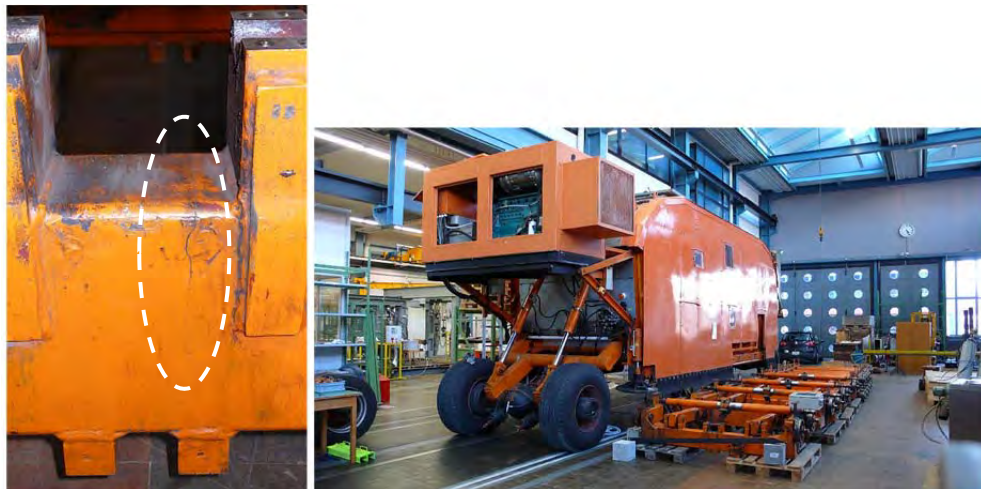
During routine control of the MLS10, an extended fatigue crack was discovered in the center of one of the bogies (Fig. 5.20). After discussion with University of Stellenbosch, new bogies were designed, constructed and installed in the machine. These work lasted several months and were carried out during winter 2008/2009.

Fig. 5.20 Crack in the old bogies (left) and replacement work carried out at Empa (right)

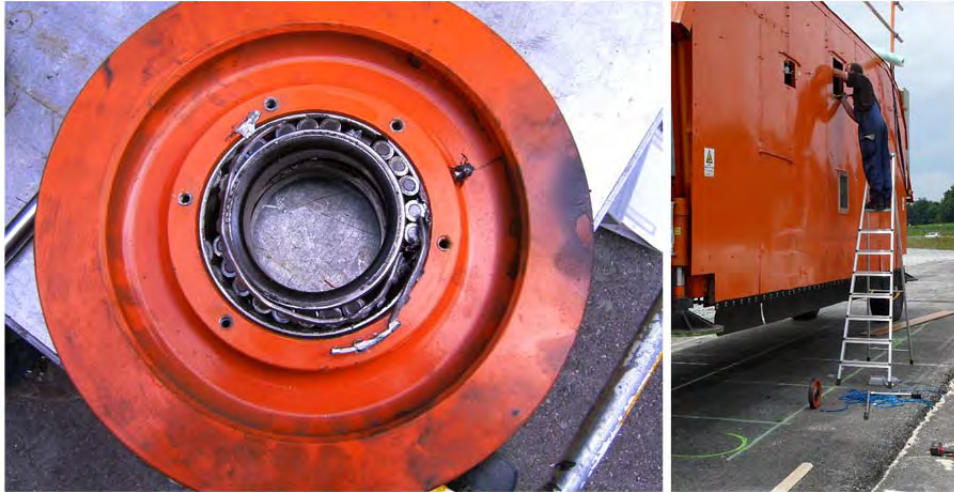
An inadequate installation of special bearings in the steel wheels of the new bogies caused breaking of one these bearings and extensive damage in one of the wheels. All bearings and a wheel had to be replaced (see Fig. 5.21). The work was carried out on site and caused a breakdown of more than 2 weeks.

*Fig. 5.21 Damaged bearing (left) and replacement work carried out in Filderren (right).*

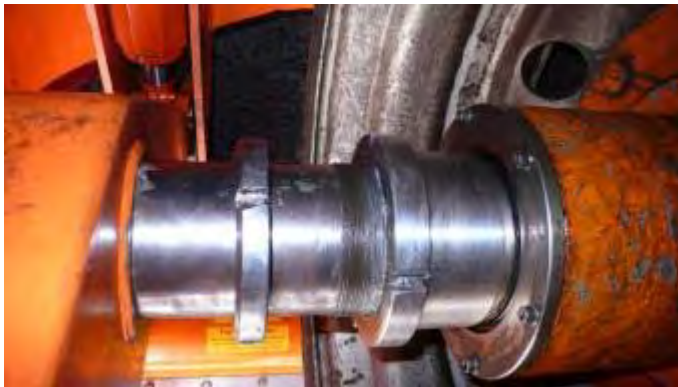
During a routine check, a problem in the fixation of the trafficking wheels was detected and the design was changed and improved (see Fig. 5.23). The repairing took several days.

*Fig. 5.22 Picture showing the insecure fixation of the trafficking wheel*

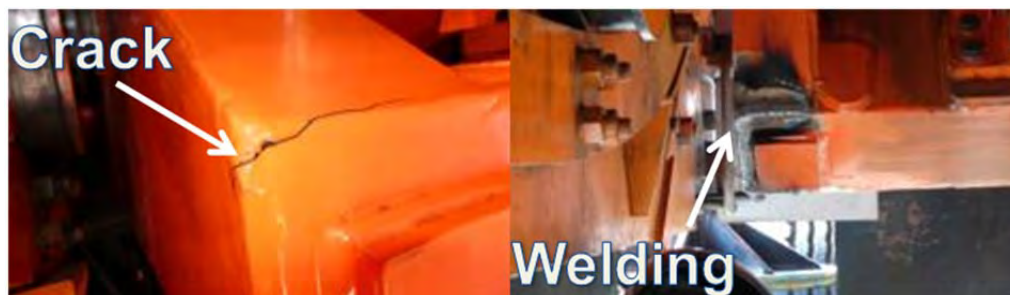
After a routine check, new fatigue cracks were discovered (see Fig. 5.23). It was decided to fix them by welding on site and to revise the design of the the bogies for later reinforcement. The problem caused a delay of more than 2 weeks.

Fig. 5.23 Crack (links) and welding (right)

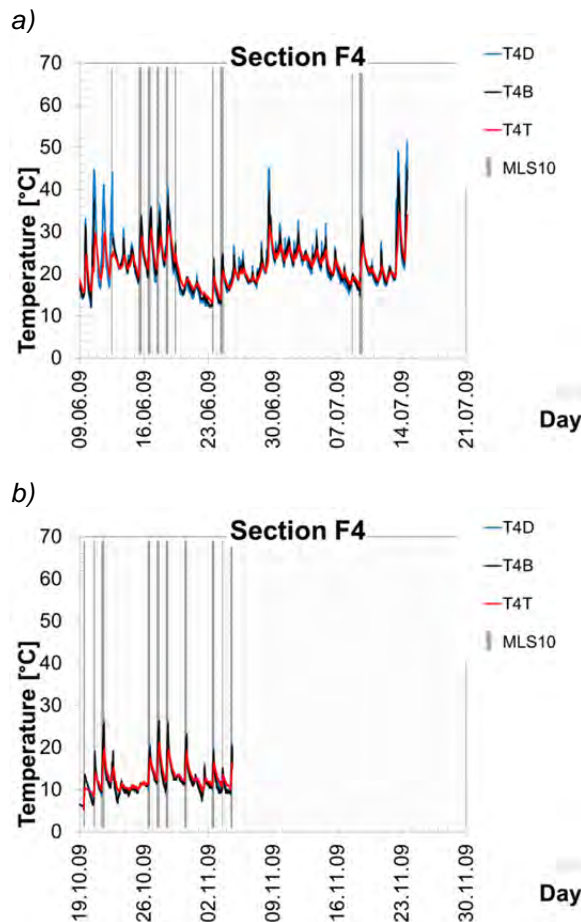
Fig. 5.27 Temperature distribution measured in section F4, for the two periods of MLS10 trafficking in a) June and July and b) October and November 2009

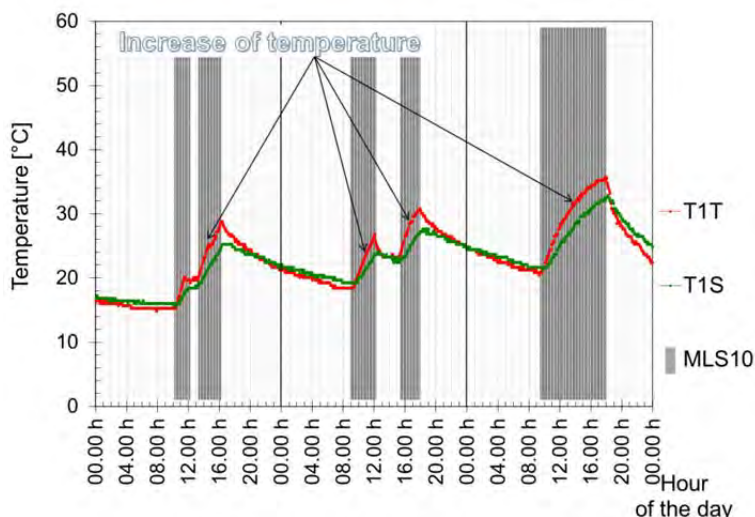
In some of the cases it can be noticed that the increase of temperature in the pavement is not only produced by the sun or the temperature of the air. There is also an increase of temperature that is partially caused by the transmission of the heat produced by the machine itself and the dissipation of the energy induced by the rolling of the tires over the pavement. This means that the pavement increases the temperature locally in the zone near the rolling tires. This can be explained as deformation energy produced by the rolling tires being transformed to heat due to internal friction in the pavement. Fig. 5.28 shows an example of this effect in section F1. The figure shows the temperature during 3 days in which the MLS10 was trafficking the section. The continuous lines show the temperature of each of the sensors in section F1 and how it grows in coincidence with the initiation of the trafficking (gray columns). As soon as the MLS10 stop trafficking the section, the temperature of the pavement decreases, even if it is during the daylight period. This means that the machine heats the pavement through the intense rolling intervals and the temperature will be always above the exterior air temperature.

Fig. 5.28 Increase of temperature due to MLS10 loading

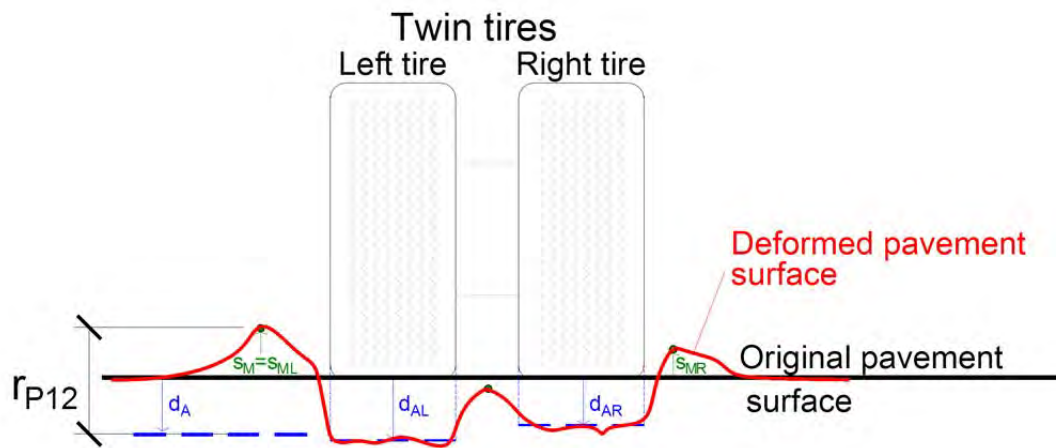
Because of channelized trafficking, the tire treads produce clear longitudinal imprints on the pavement surface. The form of the rutting is therefore different from what is usually found in a road, where vehicles wander within the lane and tires have different shapes. Estimation of rutting outlined in the SN 640925b [26], as the maximum distance between a latch sitting perpendicular to the rut and the pavement below, is thus not used for MLS10 channelized trafficking. Fig. 5.30 shows a schema of the rut depth calculation methodology employed in this report, in the case of twin tires loading.

Fig. 5.30 Example for the calculation of the rut depth from a profile measurement, where

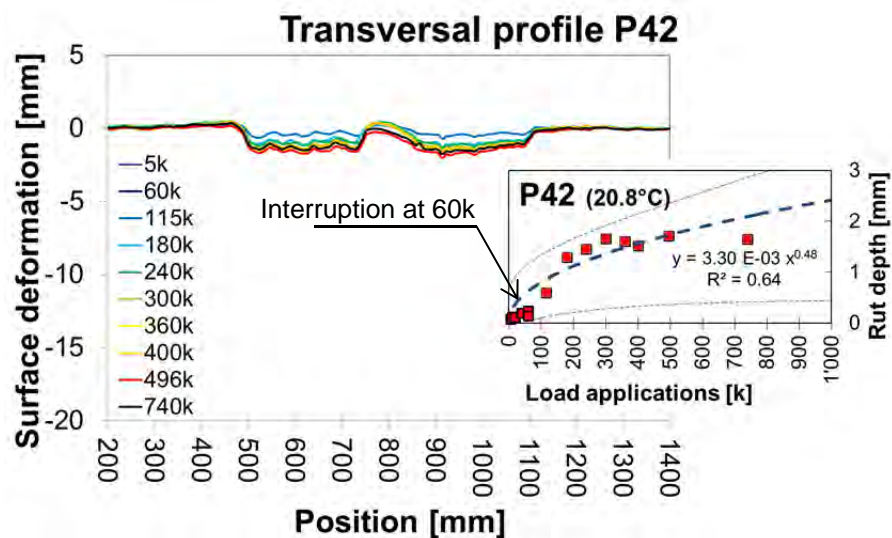
Fig. 5.33 Rutting profiles P42 measured in the middle section F4. The subfigure presents the progressive rut depth vs. number of MLS10 applications fitted with a power function, including 95% prediction bounds

In section F4, the first 60'000 load applications were carried out in year 2008. Trafficking was resumed after several months' interruption in 2009. During this break the testing field was used for other purposes and the fix references for the profile measurements were removed. Therefore, the results show a clear discontinuity in the progression trend (Fig. 5.33). This is also observed in the poor coefficient of determination  $R^2$  of the potential approximation.

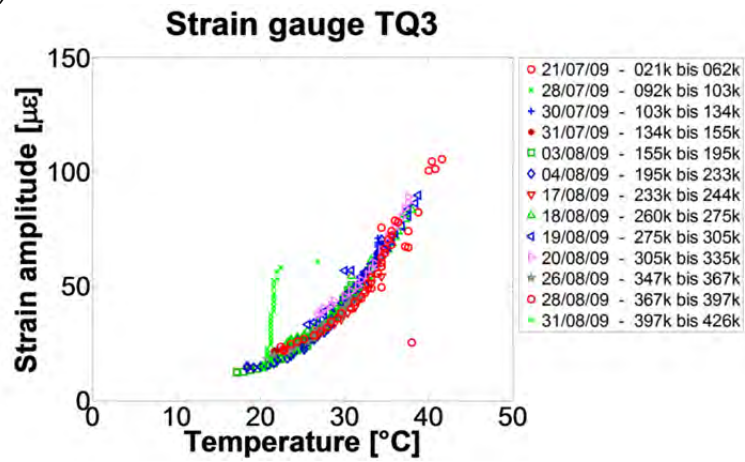
Fig. 5.39 Evolution of strain amplitudes during the course of the tests in section F3, for strain gauges a) TL3 and b) TQ3

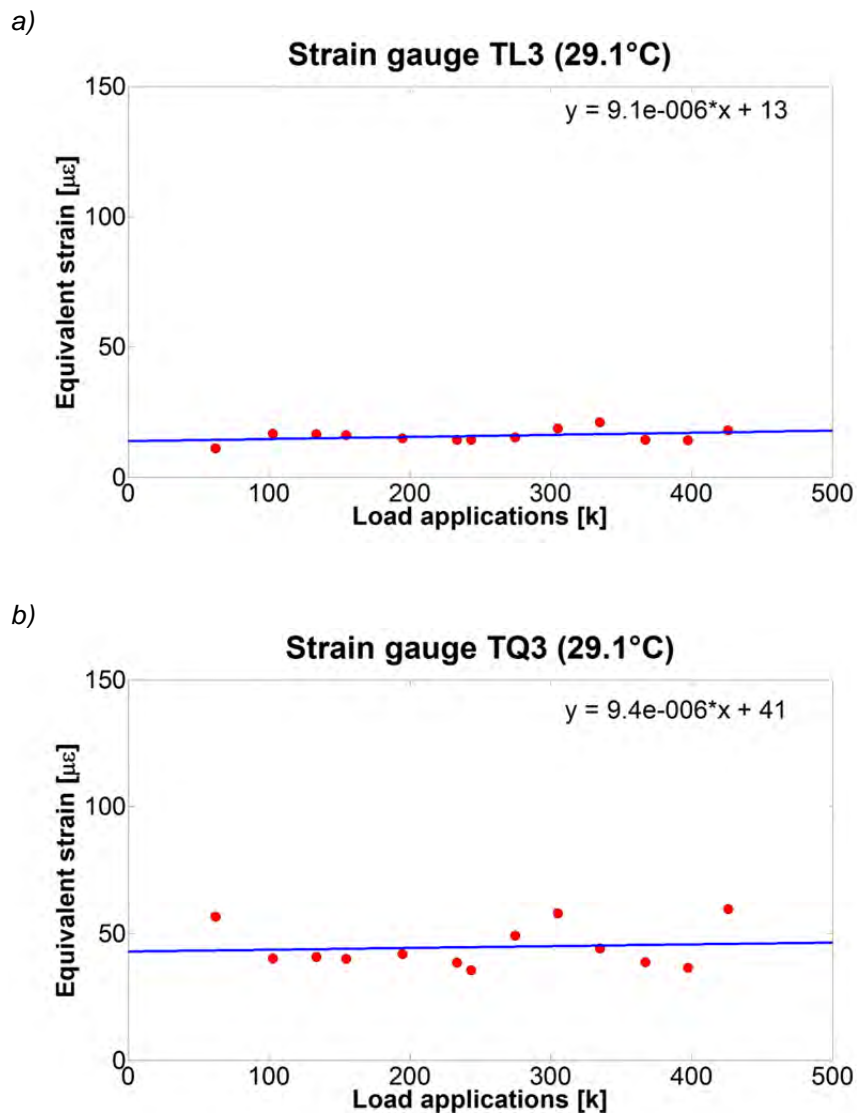
Fig. 5.40 presents the calculated equivalent strains for a temperature of 29.1°C vs. the number of MLS10 load applications. For TL3, the equivalent strains during the whole test remain constant at around 13µε. Also BQ4 results present a constant strain level at 41µε. This suggests that the pavement did not show any type of change in the mechanical properties caused by cracking or any other type of distress until the end of the tests.

Fig. 5.40 Equivalent strains vs. MLS10 load applications, calculated for the average testing temperature in section F3, for strain gauges a) TL3 and b) TQ3

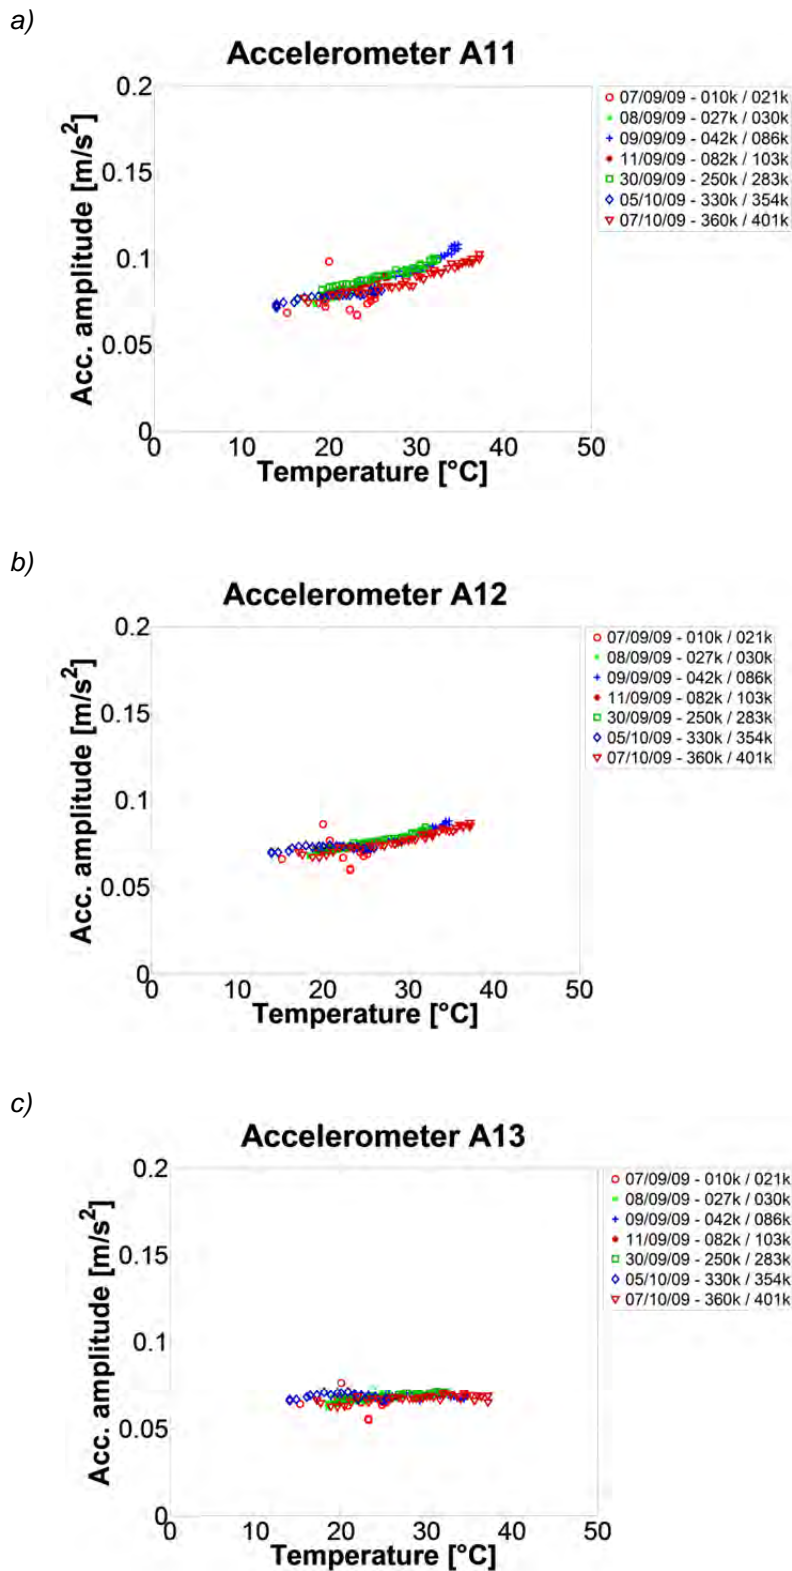
The analysis of the acceleration records following the method described in the last section shows an increasing strain amplitude with increasing temperature. As expected, the acceleration amplitude close to the load application area recorded by sensor A11 is higher than for the more far accelerometer A13. Fig. 5.46 presents the calculated equivalent accelerations in section F1.

Fig. 5.46 Acceleration amplitudes during the course of the tests in section F1, for accelerometer a) A11 and b) A12 c) A13

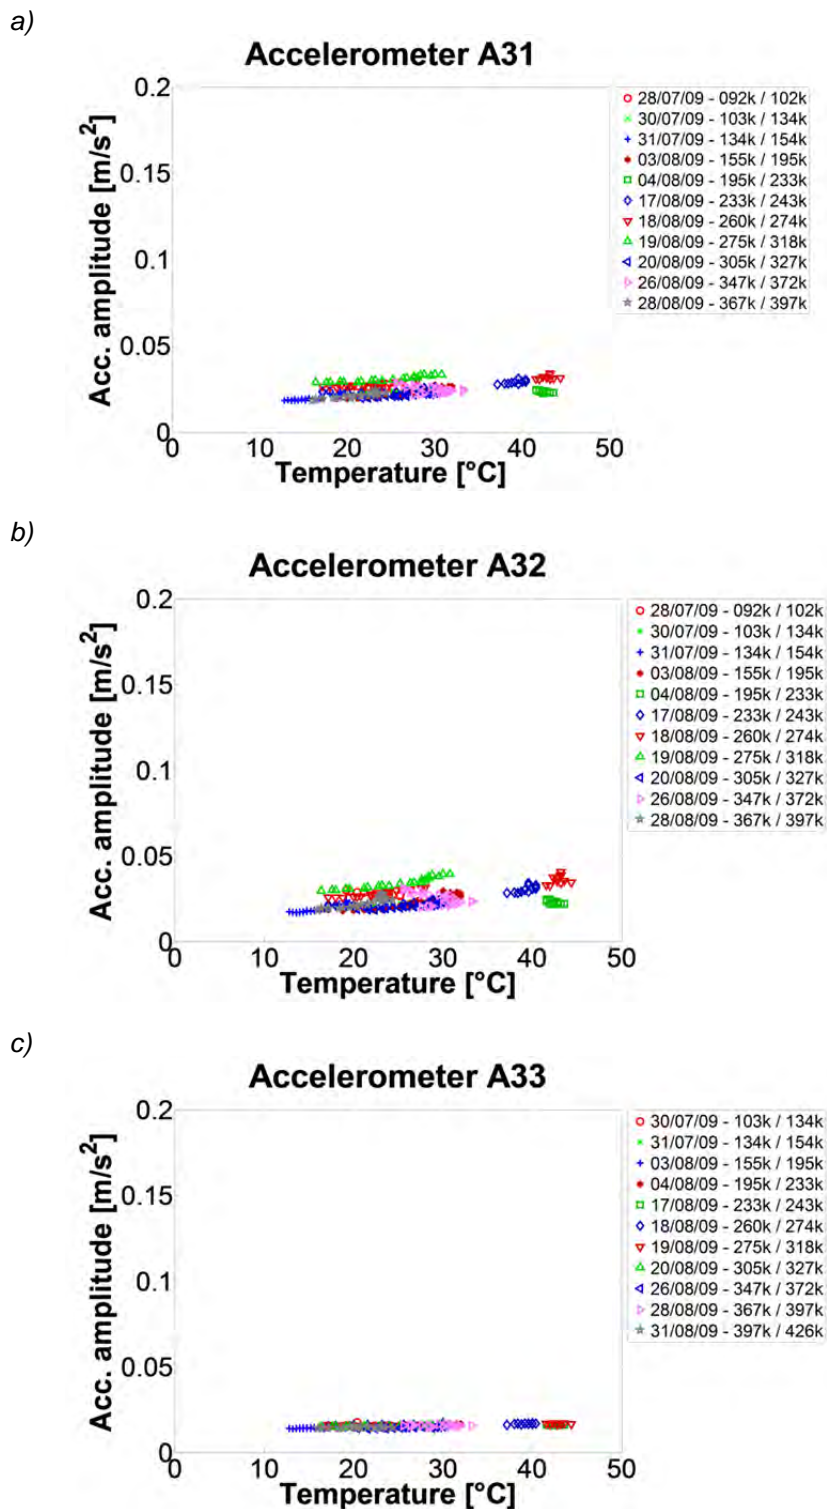
As expected, the acceleration amplitude close to the load application area recorded by sensor A31 is higher than for the more far accelerometer A33. Fig. 5.48 presents the calculated equivalent accelerations in section F3.

Fig. 5.48 Acceleration amplitudes during the course of the tests in section F3, for accelerometer a) A31 and b) A32 c) A33.

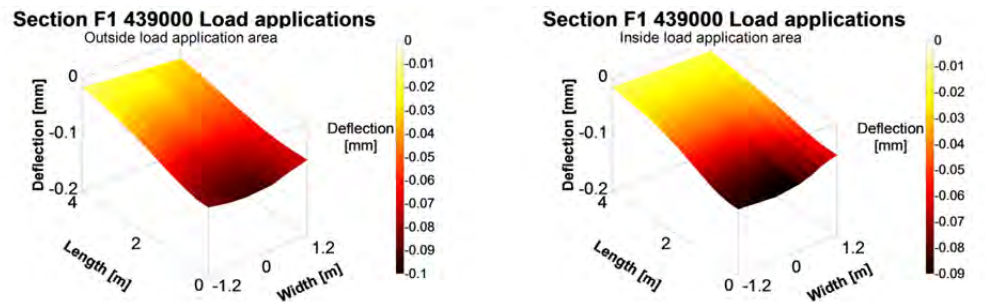
Temperature: 5.5°C

Fig. 5.56 3D graph of the deflection measured with ETH Delta for 2 trafficking conditions in section F1, outside (left) and inside (right) the load application area

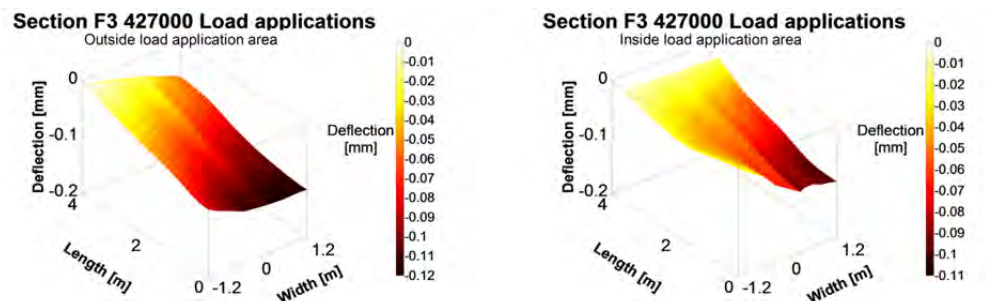
Temperature: 27.4°C

Fig. 5.57 3D graph of the deflection measured with ETH Delta for 2 trafficking conditions in section F3, outside (left) and inside (right) the load application area

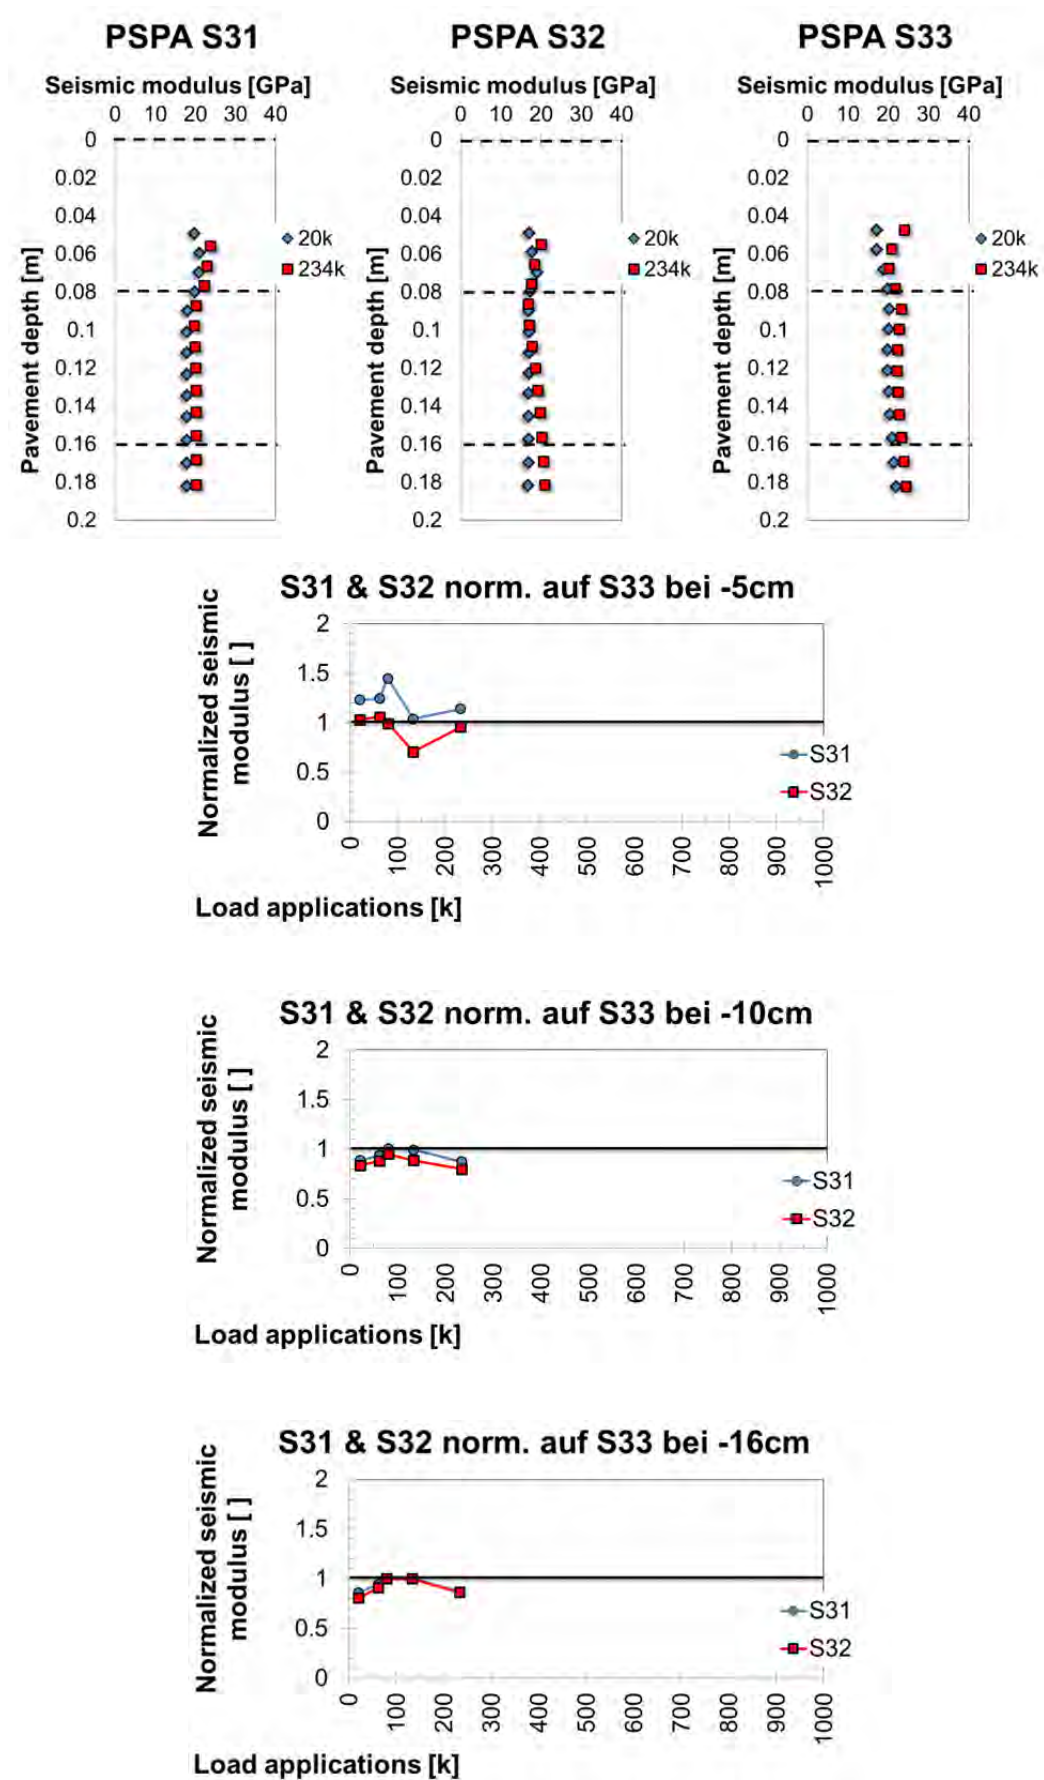
The results of the analysis are displayed in Fig. 5.60. The analysis of the general evolution at the analyzed depths indicates that the asphalt as well as the stabilization layers have an apparent seismic modulus of around 15-25GPa. There is no clear change in stiffness between the layers. The seismic stiffness measured near the surface (at -5cm) shows the biggest difference among points. However, the normalized values indicate that there is no clear change in both the stiffness trend throughout the tests and the stiffness in the trafficked area (S31 and S32). For the other depths (-10cm and -15cm) stiffness is even more homogenous with no significant change after trafficking.

Fig. 5.60 Evolution of seismic modulus vs. depth and number of load applications for section F4.

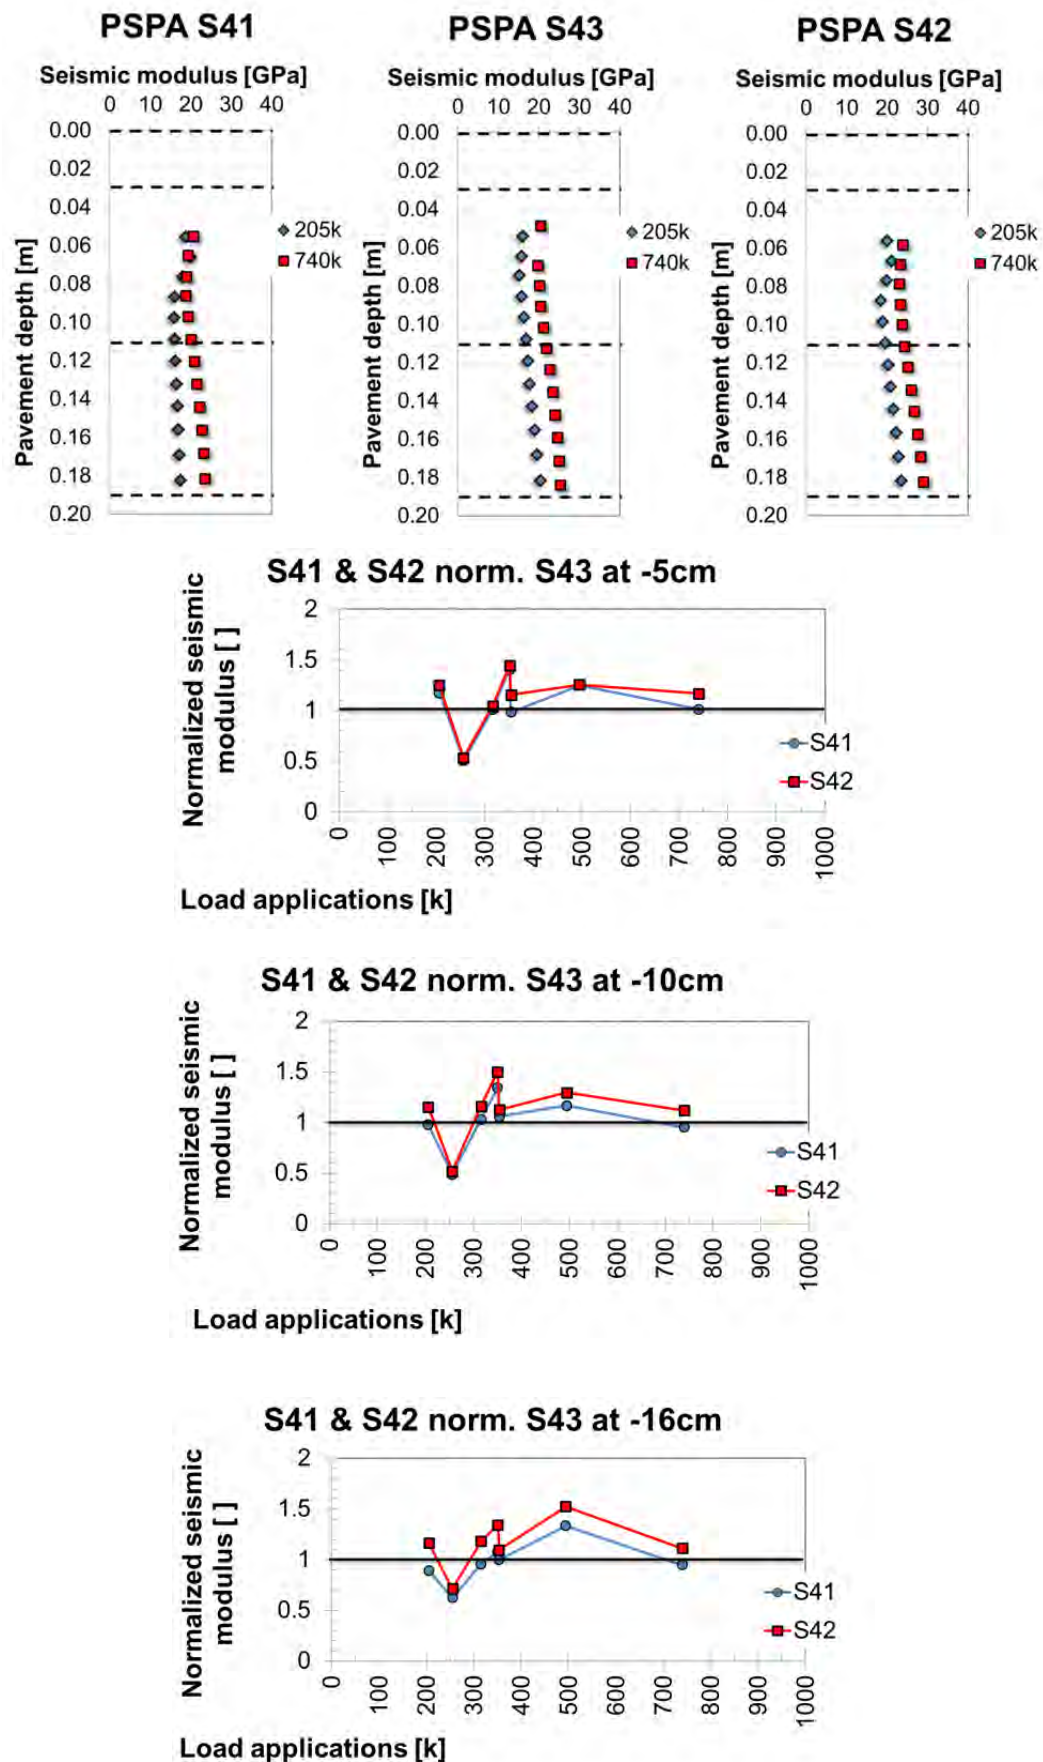
The results of the analysis in section F4 are displayed in Fig. 5.61. The asphalt layers have an apparent seismic modulus of around 15-25GPa, with a peak at S43 of almost 30GPa. If this peak is not considered (the stiffness should not increase that much for the not-trafficked area), it can be seen that there is a small tendency for the stiffness to increase in the trafficking path. However, this change is not significant enough to draw conclusions about changes in the stiffness of the layers after trafficking.

Fig. 5.61 Evolution of seismic modulus vs. depth and number of load applications for section F4.

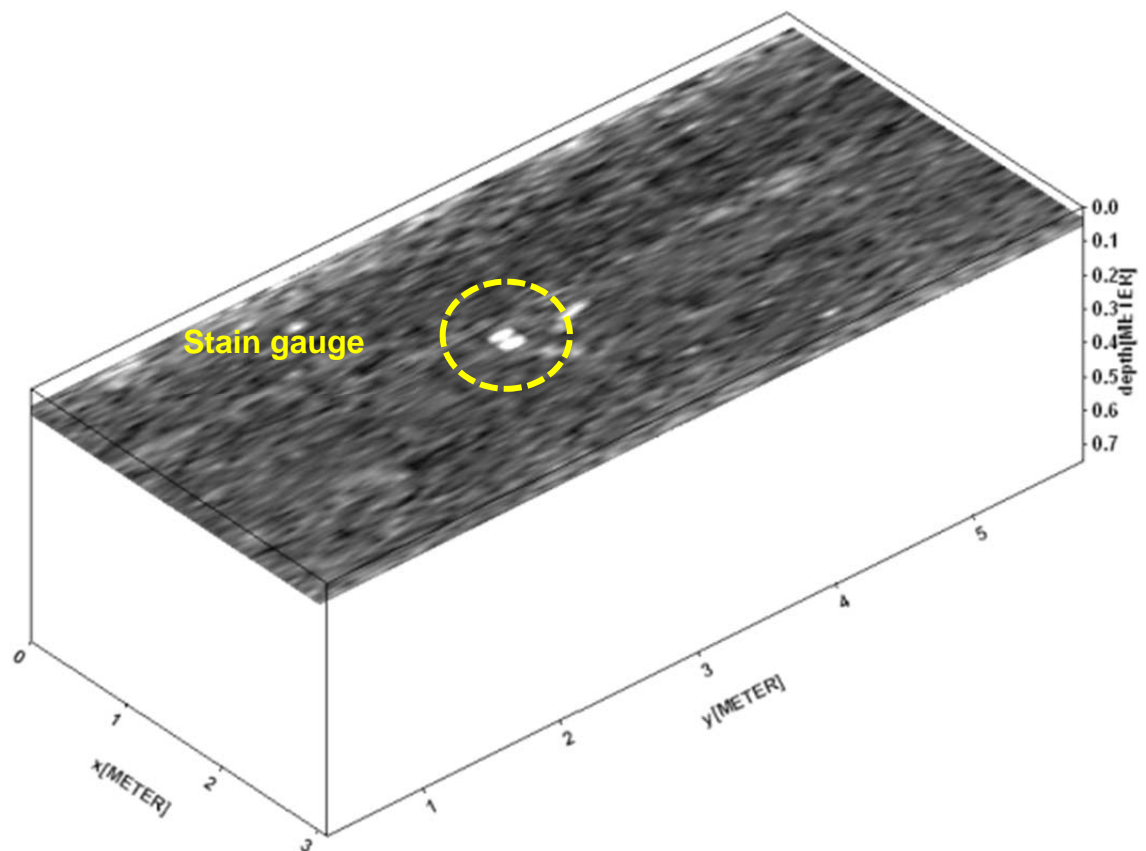
Therefore, one measurement was carried out before loading the pavement and one at the end of the tests in section F4. Unfortunately, due to a problem in the data acquisition system, the data of the last measurement was not valid and it was not possible to carry out the comparison.

Fig. 5.62 GPR inspection showing the strain gauge BQ4 before loading.

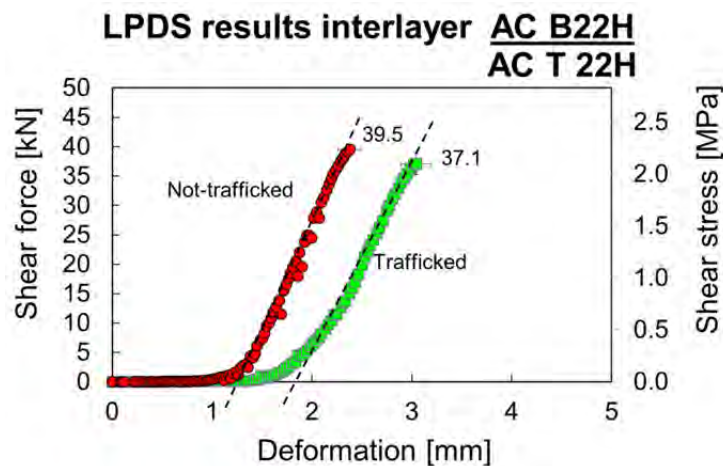
Fig. 5.68 Comparison of the LPDS test results for both not-trafficked and trafficked loading condition in each interlayer.

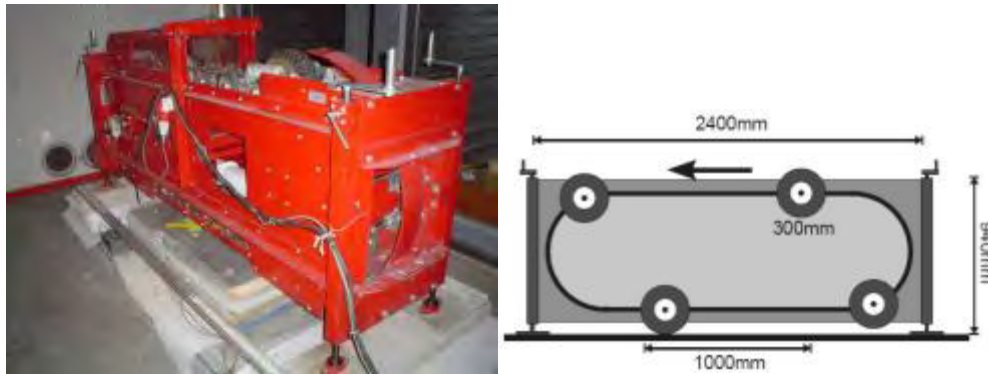
As part of the master thesis of Andrés Pugliesi from University of Rosario (Argentina) [2], a comparison was carried out between the pavement response to the full scale load simulator MLS10 in the field and to the down-scaled model mobile load simulator MMLS3 in the laboratory. The MMLS3 is a one-third scaled version of the MLS10 and the principles of operation are similar. The configuration of the MMLS3 equipment is simple and consists of four wheels of 300mm diameter, each loading the pavement with a maximum of 2.1kN using a spring suspension system, at a maximum speed of 2.5m/s (9km/h). This speed allows reaching up to 7200 load applications per hour. In this case, the wheel load is applied over a length of about 1.0m. A view and schema of the equipment is presented in Fig. 5.69.

Fig. 5.69 View and schema of the MMLS3.

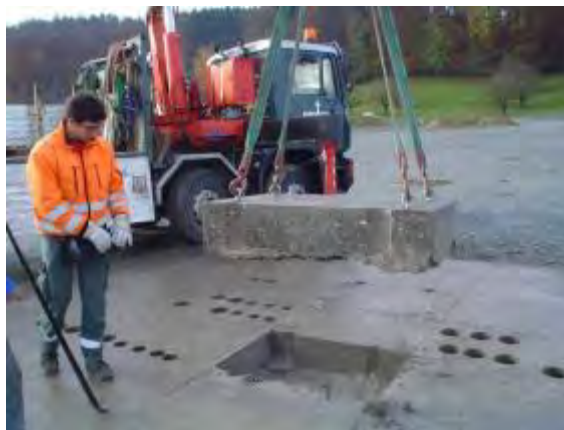
After the field experience with MLS10, a total of 6 pavement slabs 1100mm x 700mm were taken out from the trafficked area. Due to the high adhesion of the SAMI between the asphalt and the stabilized layer, the removal was difficult, and as a result the thickness of the slabs was variable (see Fig. 5.70). This was corrected by embedding the slabs in concrete.

Fig. 5.70 Pulling out of one of the pavement blocks
