## **Praxis-Kalibrierung der neuen mobilen Grossversuchsanlage MLS10 für be- schleunigte Verkehrslastsimulation auf Strassenbelägen in der Schweiz**

**Performance-Calibration of the novel full-scale test ma-  
chine MLS10 for accelerated traffic simulation on Swiss  
roads**

**Empa, Eidgenössische Materialprüfungs- und Forschungsanstalt**  
**Martin Arraigada, Dr., dipl. Ing.**  
**Manfred N. Partl, Prof. Dr., dipl. Ing. ETH**  
**Hiroyuki Kato, dipl. Ing.**  
**Andrés Pugliesi, dipl. Ing.**  
**Andreas Treuholz, Msc.**

**Forschungsauftrag ASTRA 2007/011 und ASTRA 2010/005\_OBF auf  
Antrag des Bundesamtes für Strassen (ASTRA)**

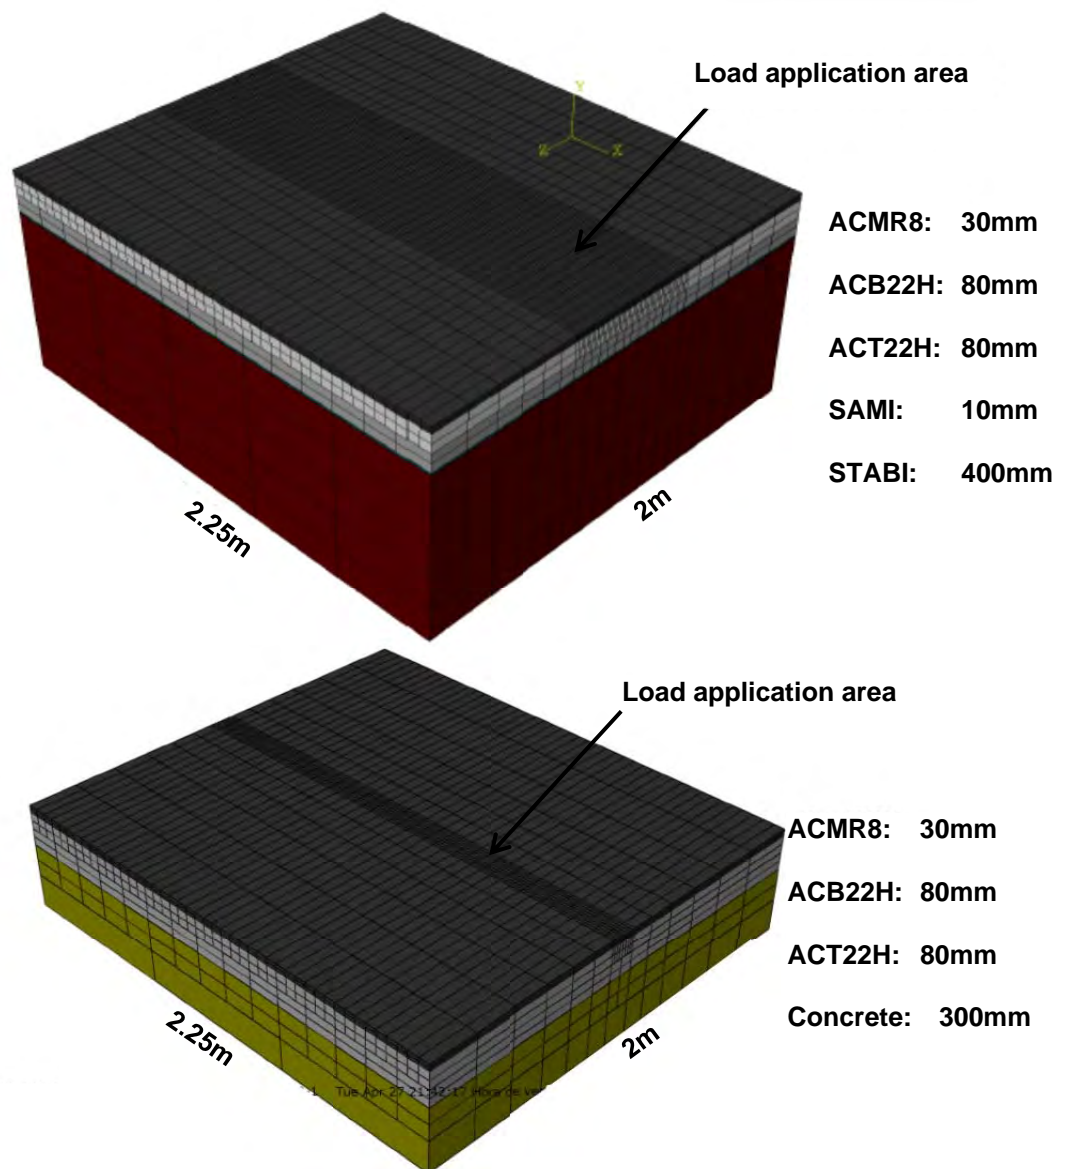
Fig. 5.72 View of the geometry of the models. On top, MLS10 model and on the bottom the MMLS3 model

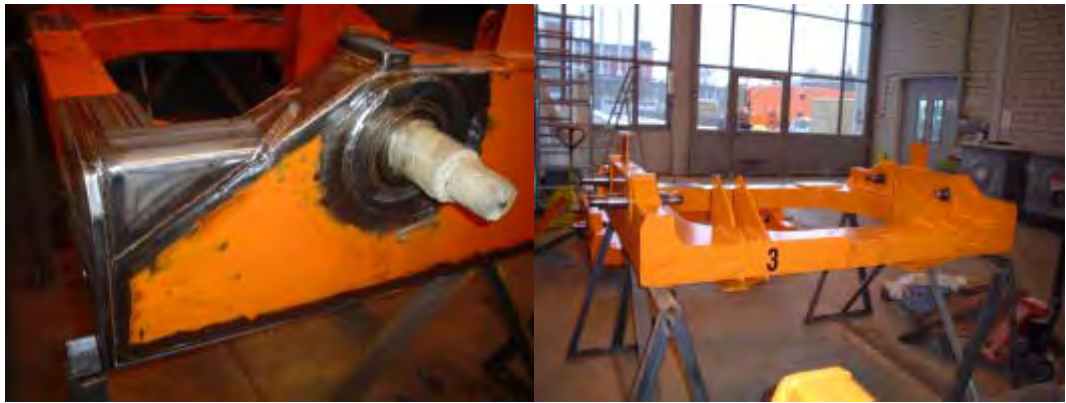
*Fig. 6.1 View of bogie reinforcement*

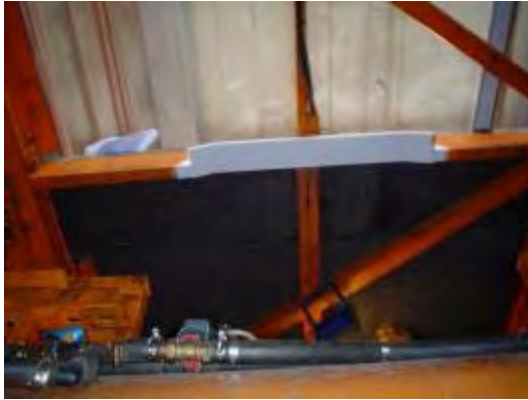
Due to the alterations in the geometry of the bogies, the frame of the machine had to be changed to let the running parts move without touching the construction and to make the structure fit for super single tires (Fig. 6.2)

*Fig. 6.2 Change in a beam of the frame*

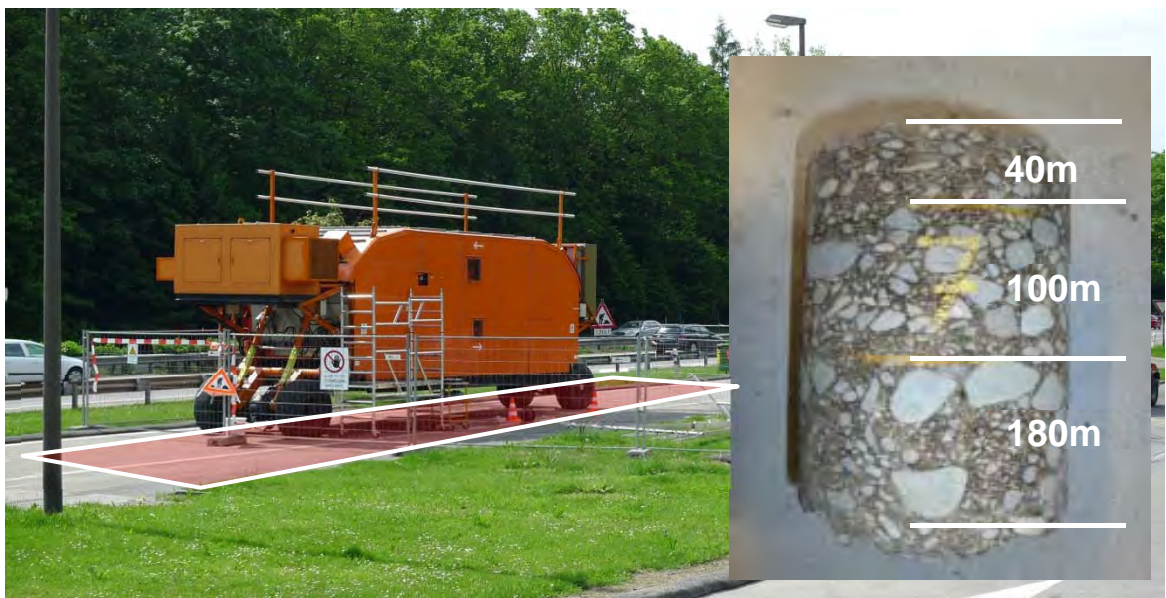
The test site was located on a by-pass road section for a rest area of highway A1, direction Bern (see Fig. 6.3). The rest area called “Rastplatz Suhr” was closed to traffic for a little more than one month in summer 2010.

*Fig. 6.3 View of testing site and thickness of the pavement*

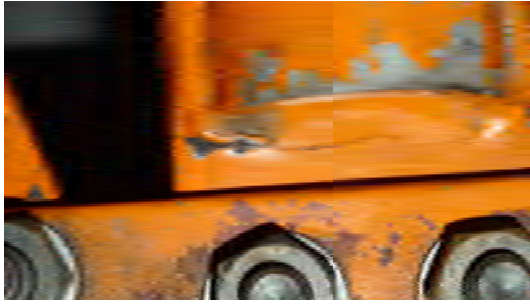
*Fig. 6.6 Crack in a strut connection*

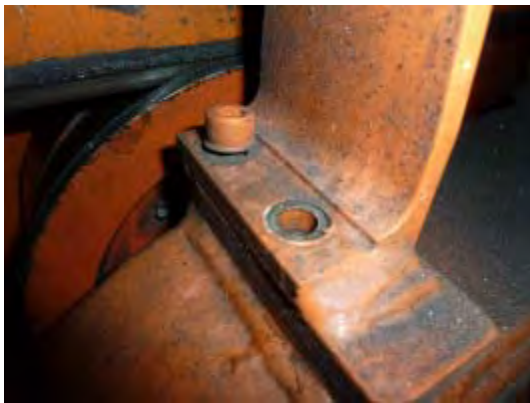
*Fig. 6.7 Failure of a bolt in a C-Bracket*

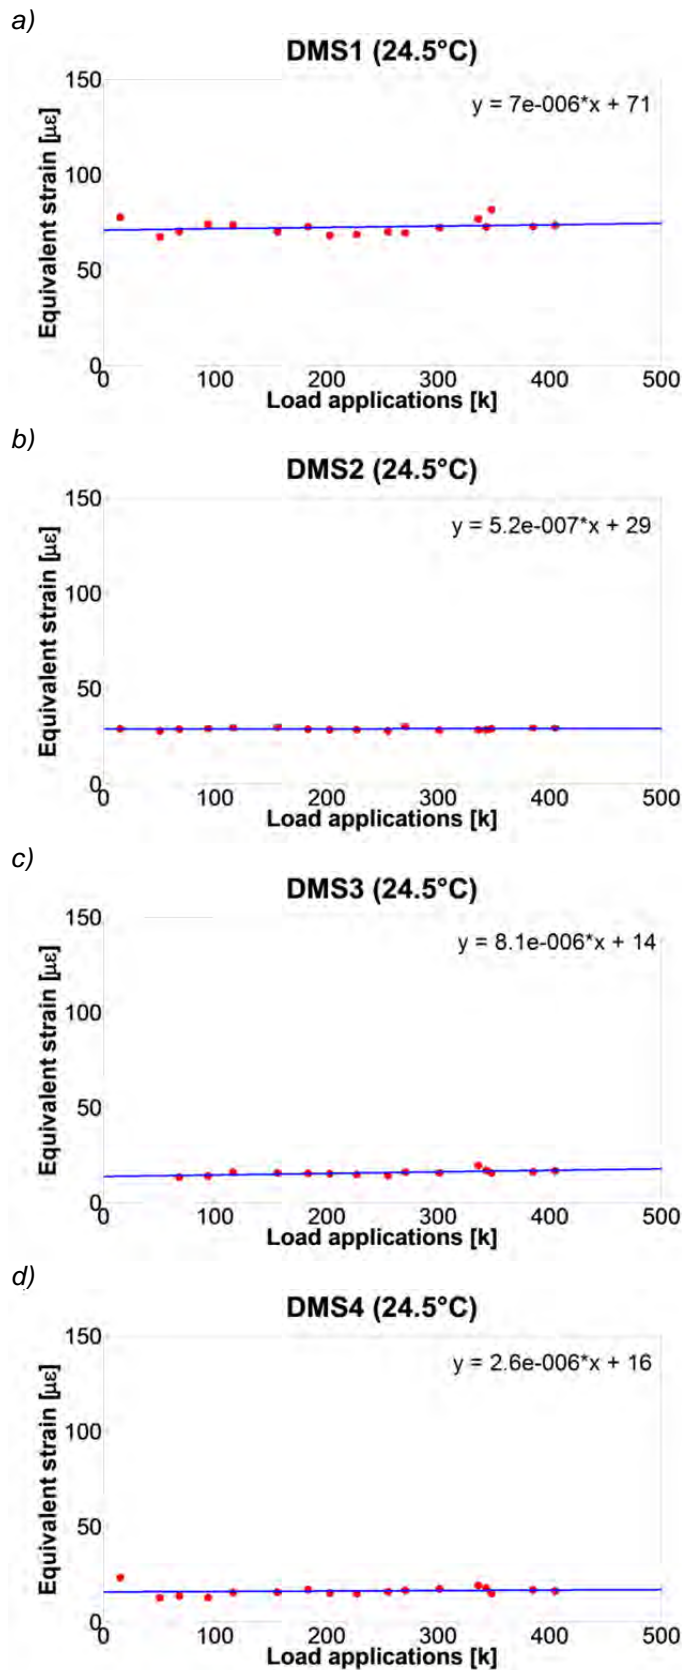
Fig. 6.15 Equivalent strains during the course of the tests and equivalent strains vs. the number of MLS10 load cycles.

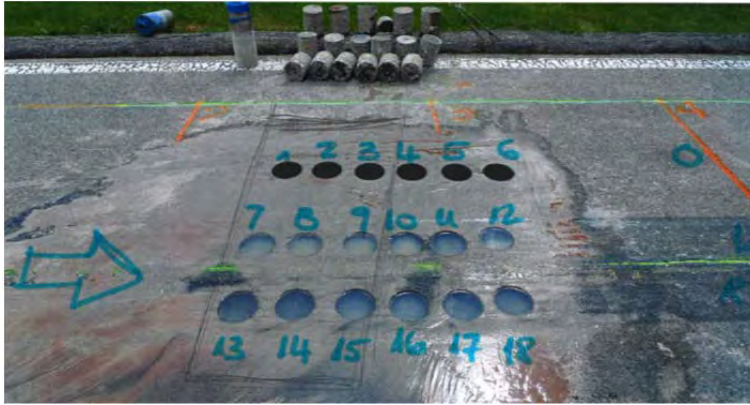
Several cores were taken from the trafficked and not-trafficked areas for conducting different laboratory tests. The position and labelling of the cores is shown in Fig. 6.22. Coring comprised only the bituminous layers. After a visual inspection of the cores and from their smell, it was concluded that the second layer from the top was probably a tar containing mixture. Therefore, it was decided not to carry out any further laboratory test with the cores other than the layer parallel direct shear test (LPDS) to check for interlayer bonding properties.

Fig. 6.22 Position and labelling of the cores

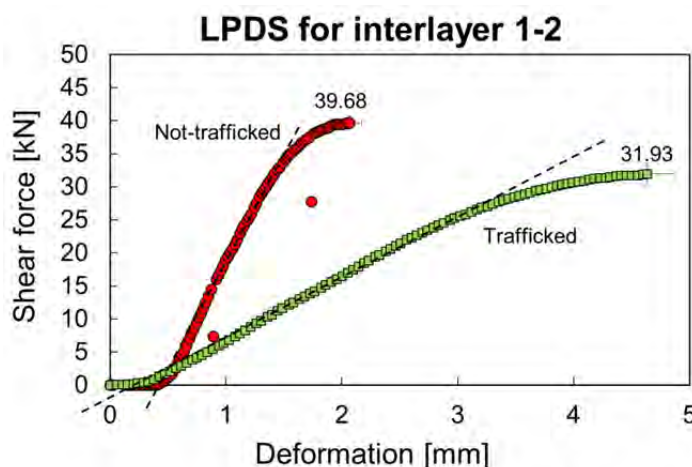
Fig. 6.23 Comparison of the LPDS interface test results between top and binder course for both not-trafficked and trafficked cores.

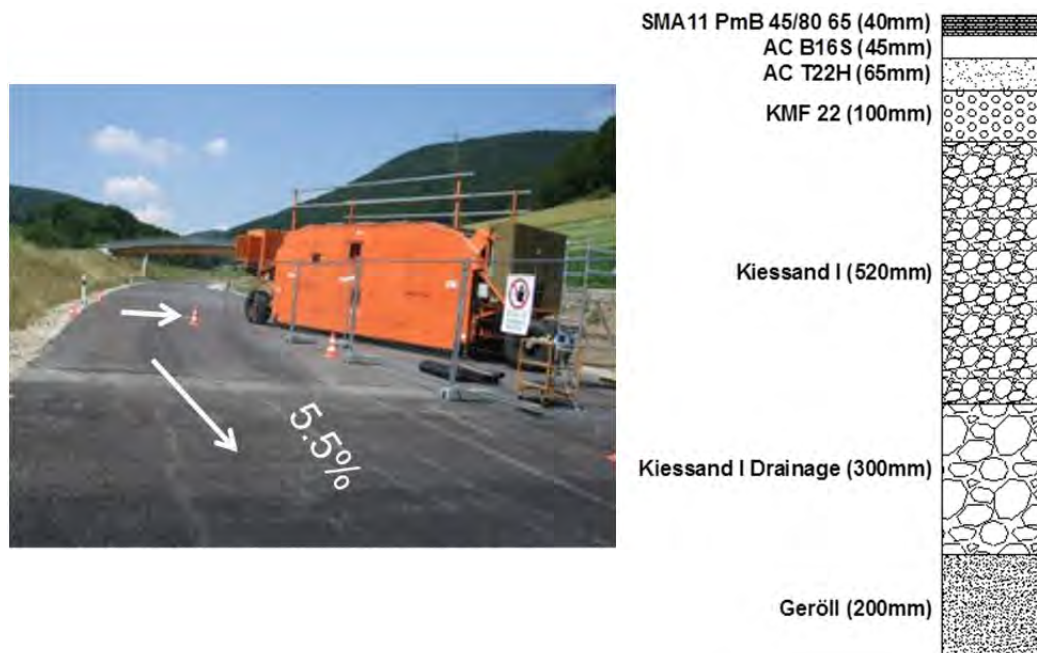
Fig. 7.1 View of testing site and thickness of the pavement.

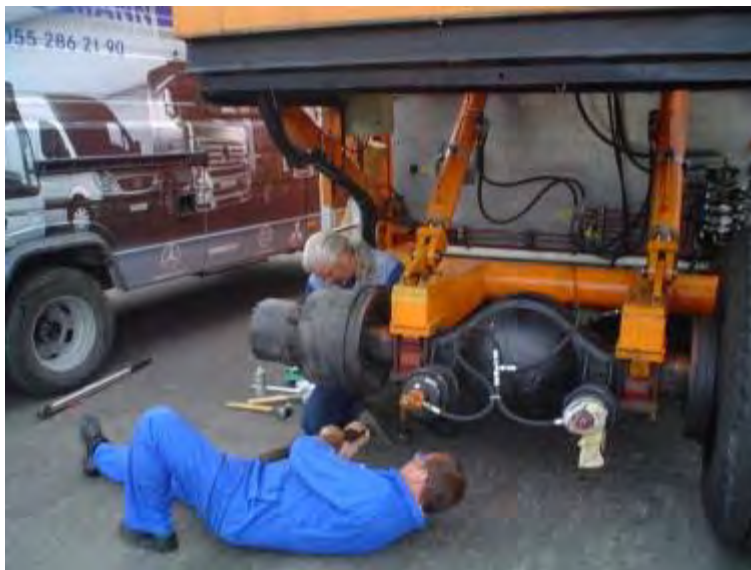
Fig. 7.5 Revision of the machine breaks.

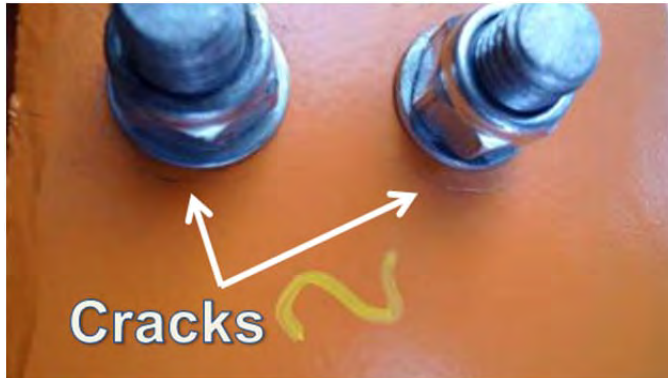
*Fig. 7.6 Crack in a bolt fixation area*

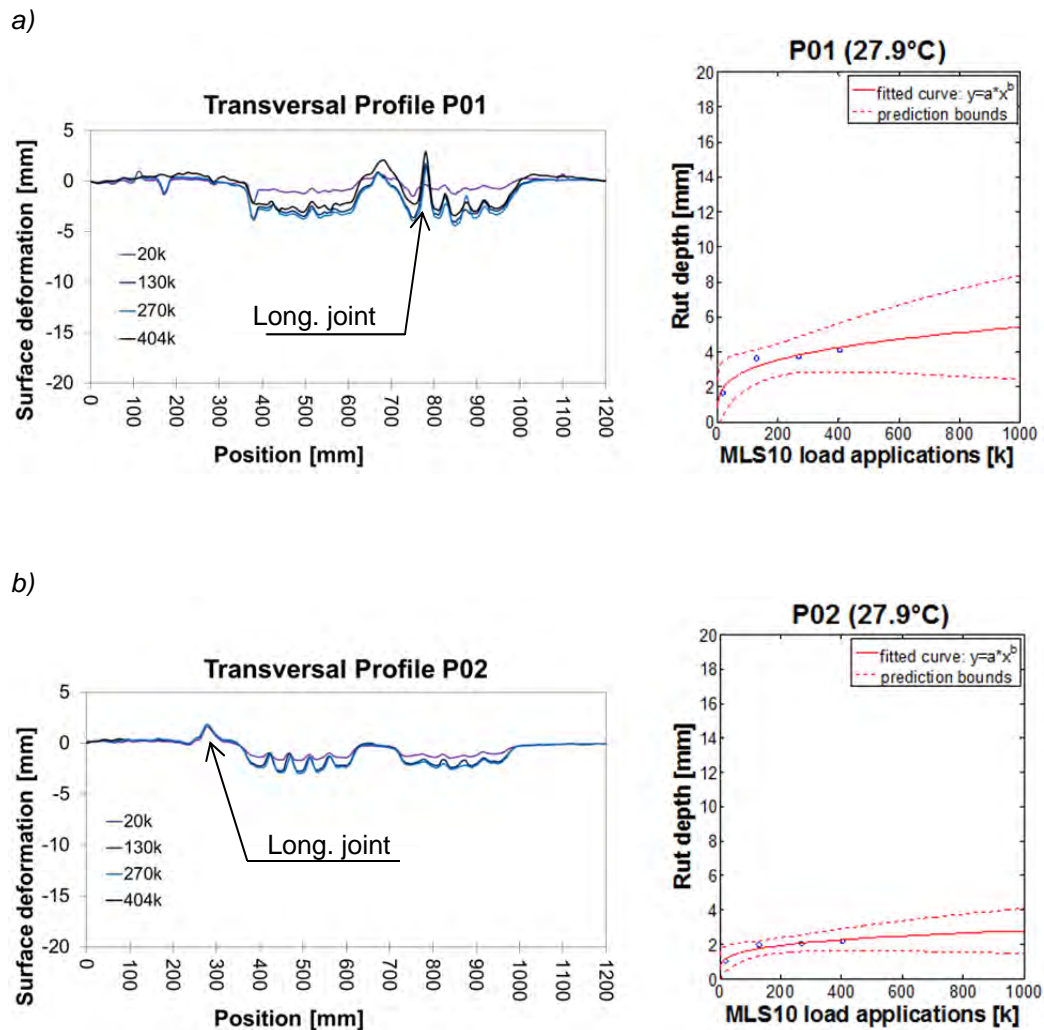
Fig. 7.9 Measured permanent vertical deformation and progressive rut depth vs. number of MLS10 load applications fitted with a power function, including 95% prediction bounds. For positions P01 and P02.

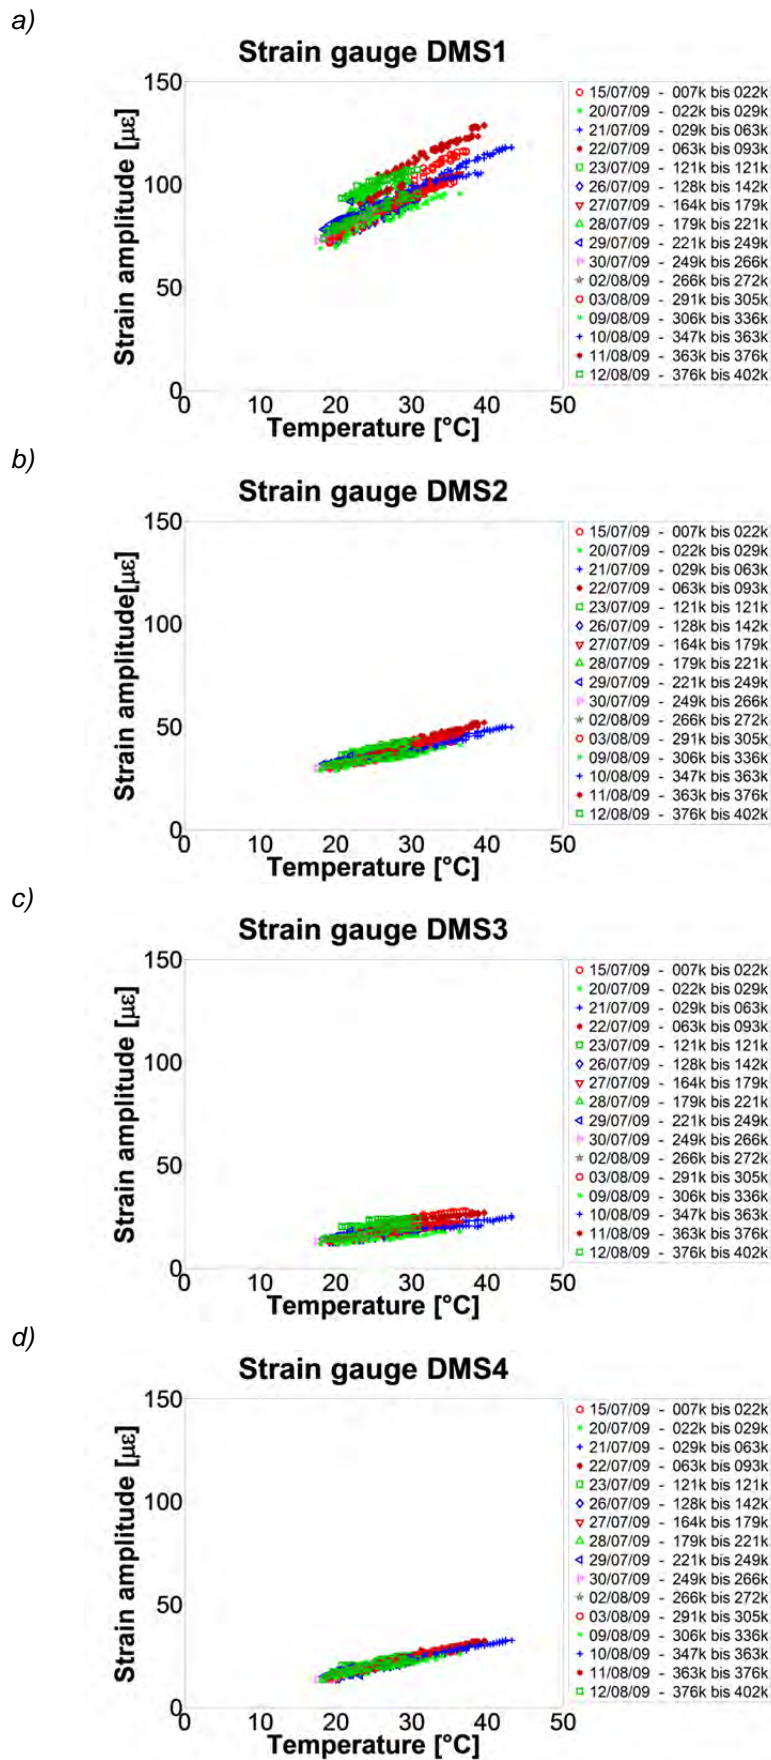
Fig. 7.12 Evolution of strain amplitudes during the course of the tests.

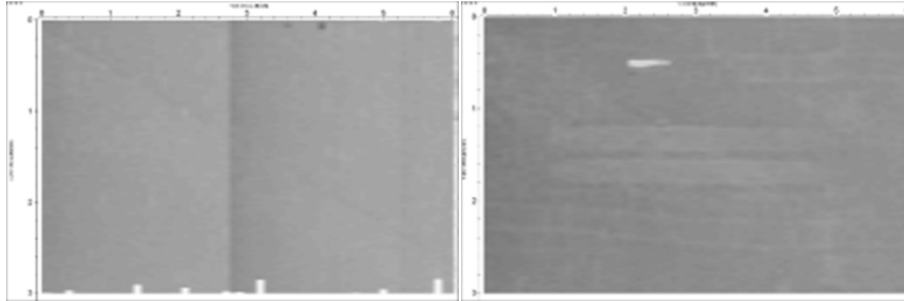
Fig. 7.30 1.5GHz antenna before (left) and after (right) trafficking.

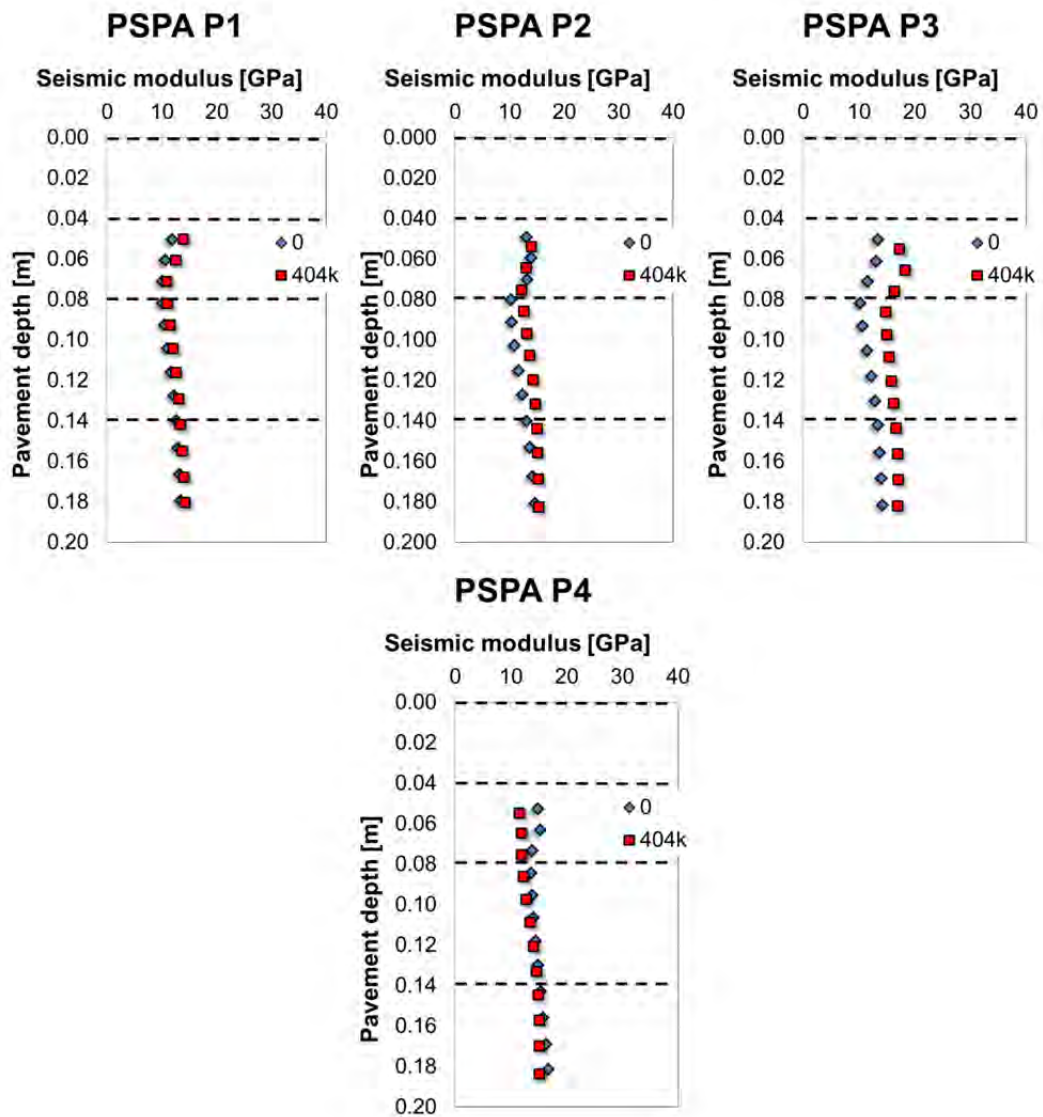
Fig. 7.44 Seismic modulus from PSPA measurements versus depth before and after trafficking with 404'000 load applications at pavement positions P1..P4

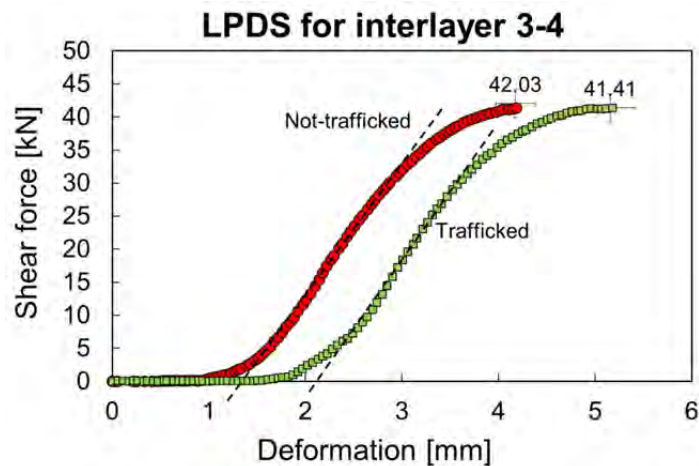
Fig. 7.48 Comparison of the LPDS test results for both not-trafficked and trafficked loading condition in each interlayer.

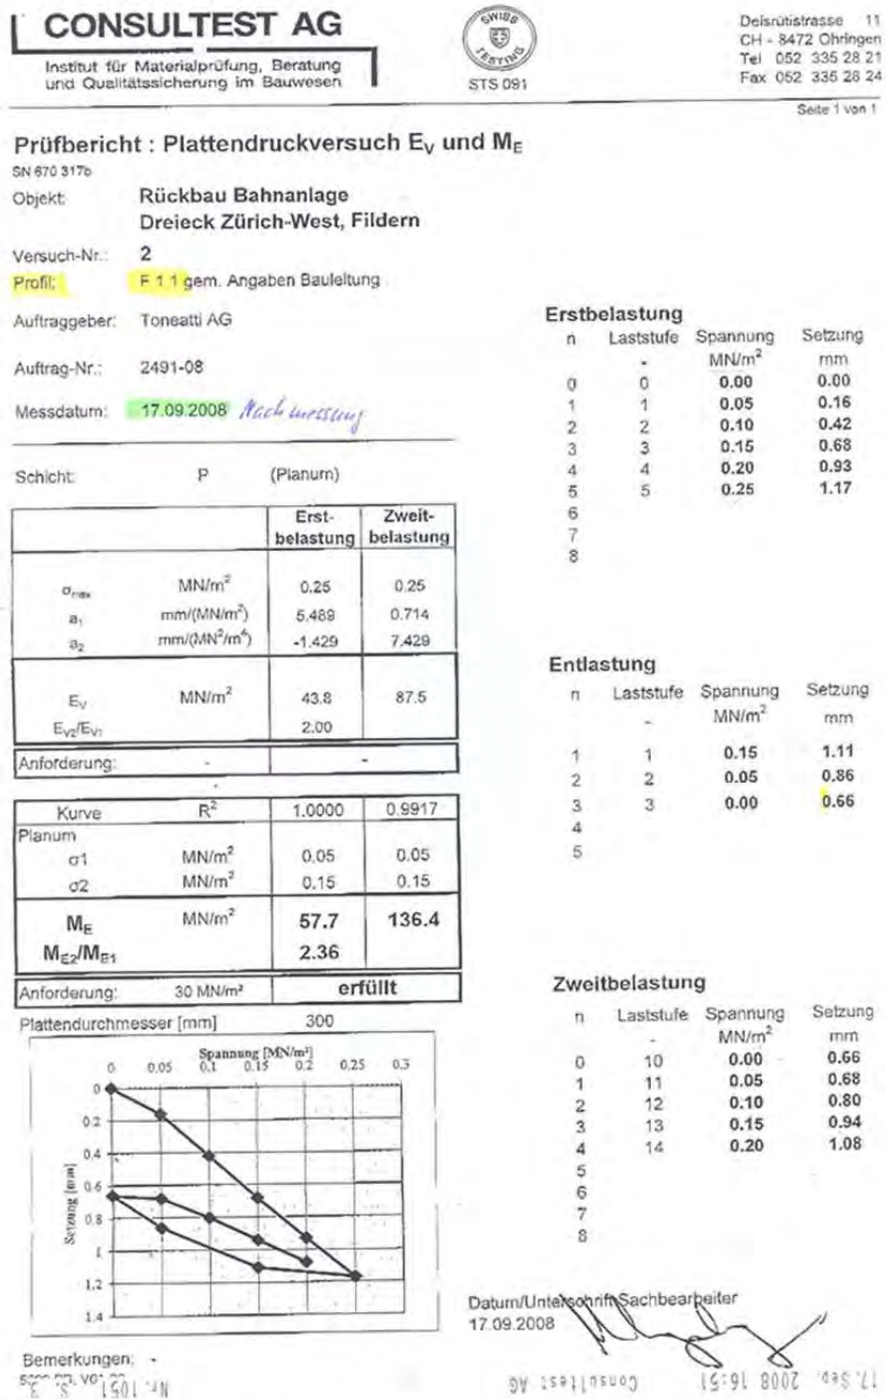
Fig. I.2 Static plate bearing test results Nr. 1 of the subgrade in section F1.

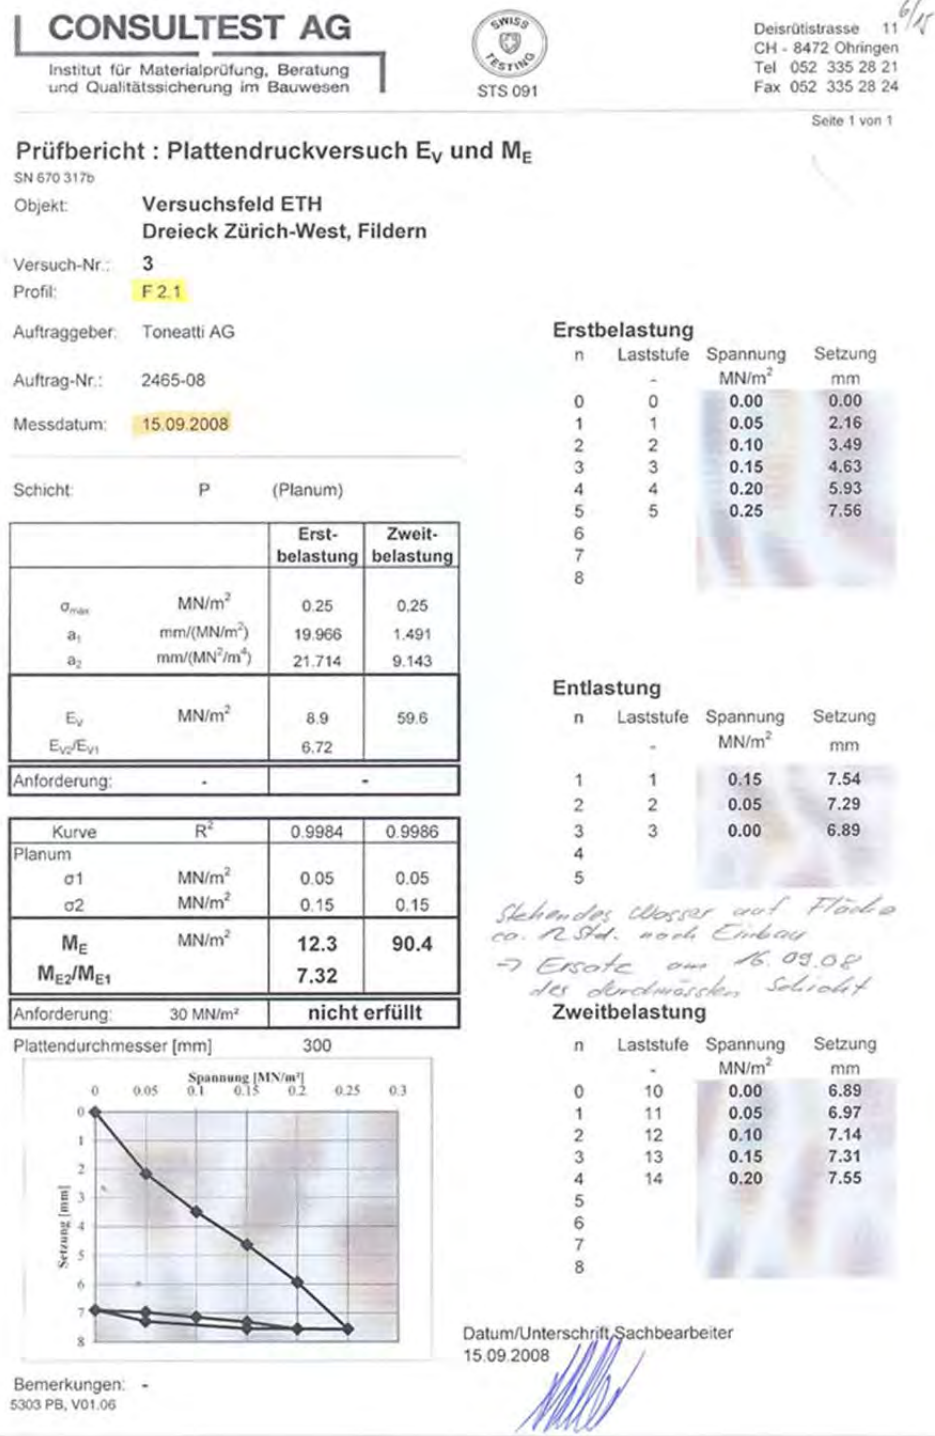
Fig. I.4 Static plate bearing test results Nr. 1 of the subgrade in section F2.

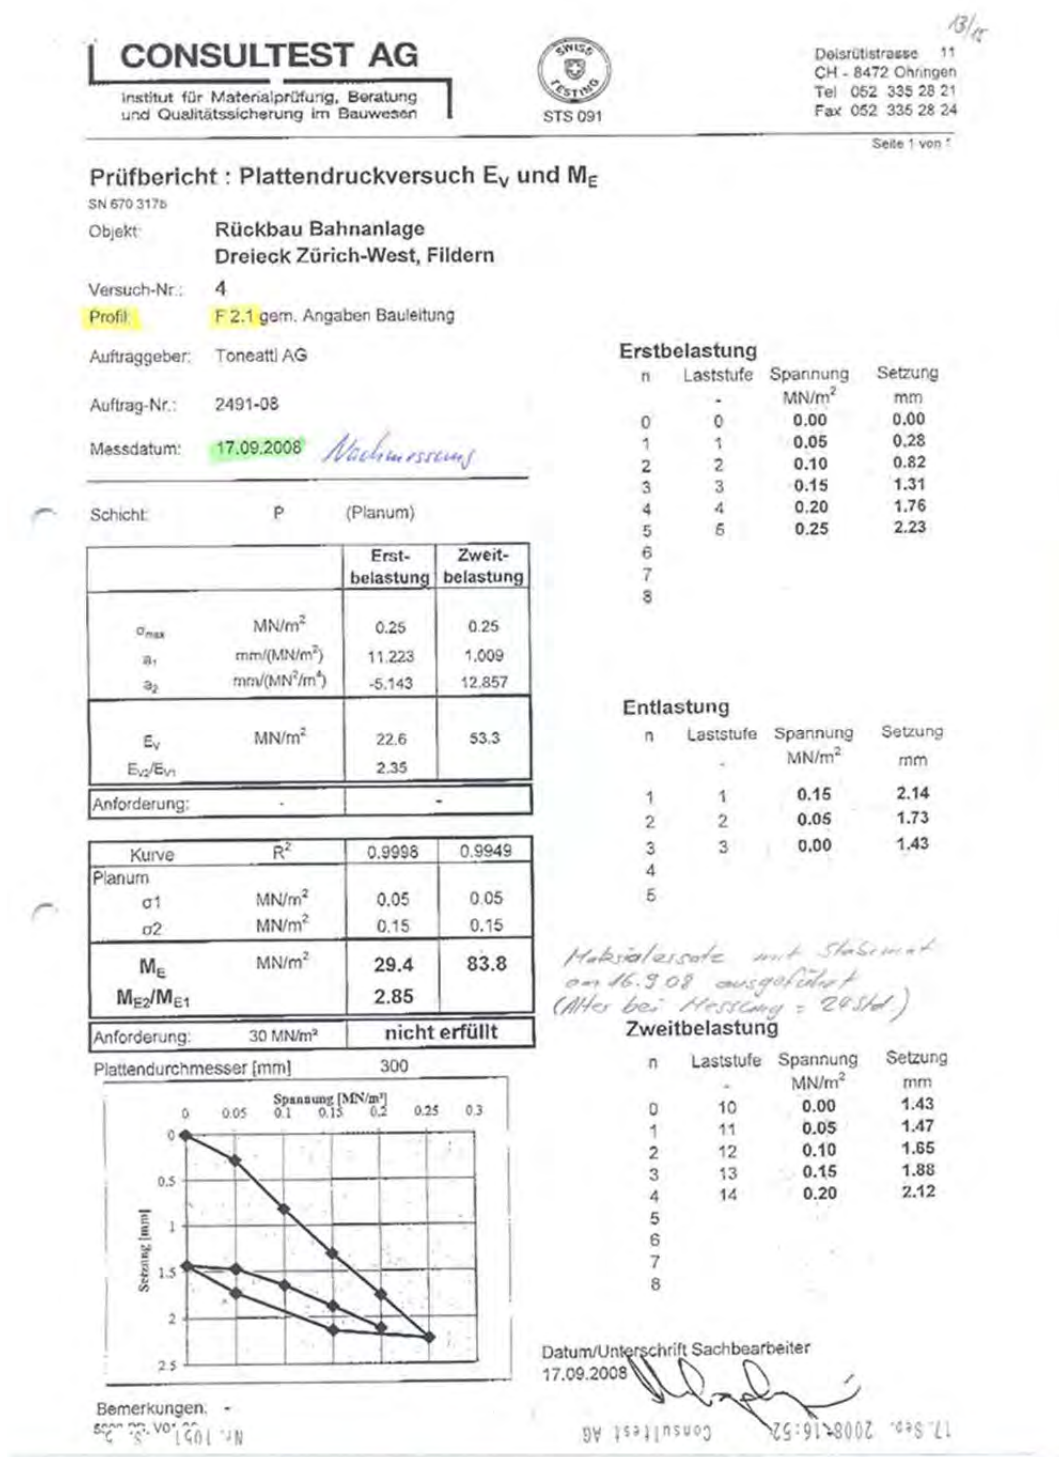
Fig. I.5 Static plate bearing test results Nr. 2 of the subgrade in section F2.

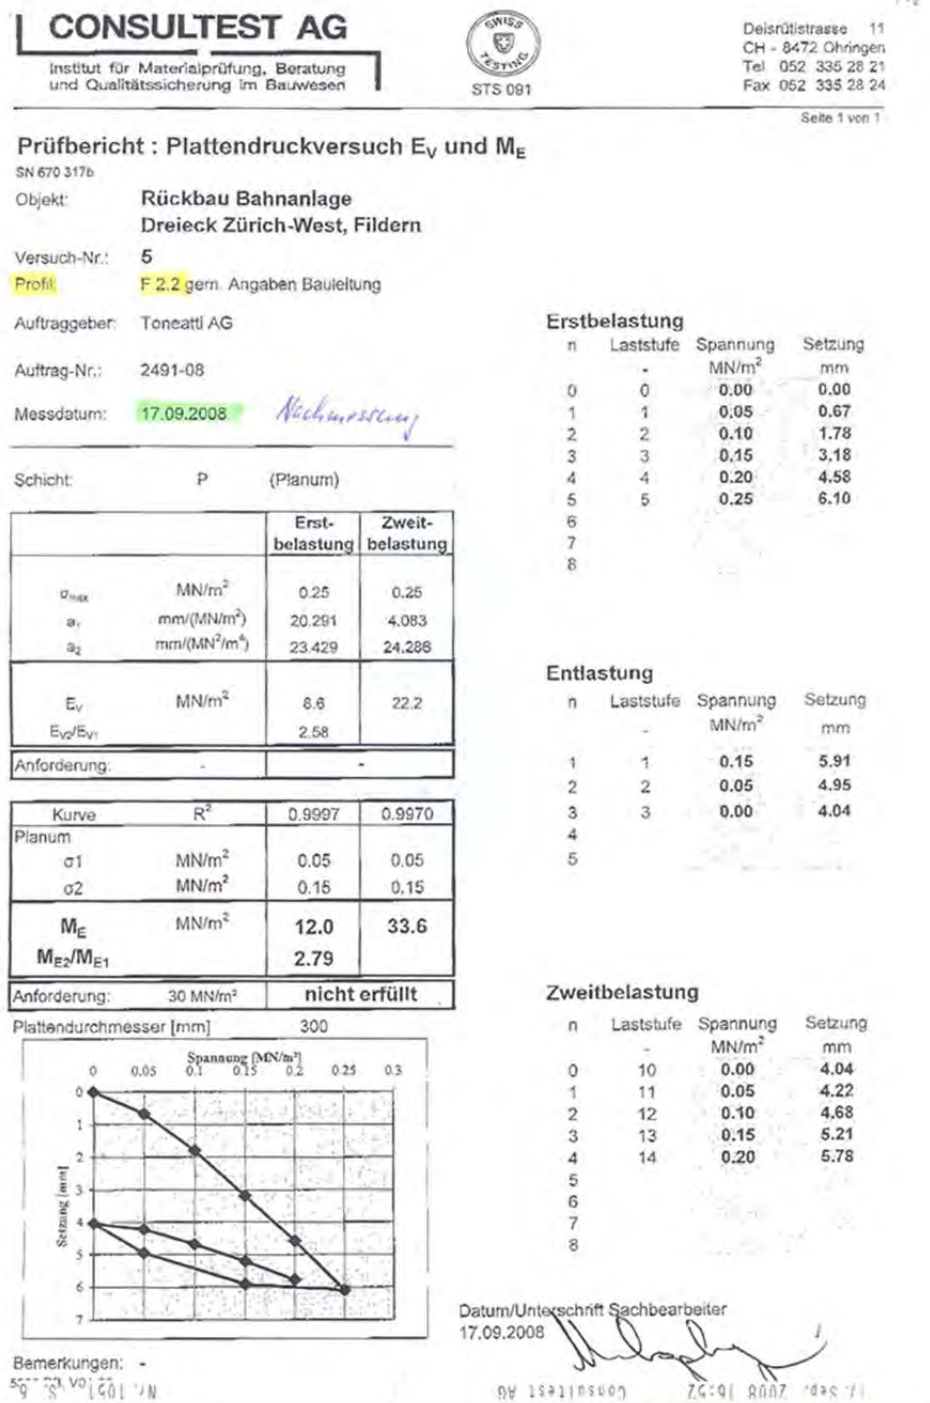
Fig. I.6 Static plate bearing test results Nr.3 of the subgrade in section F2.

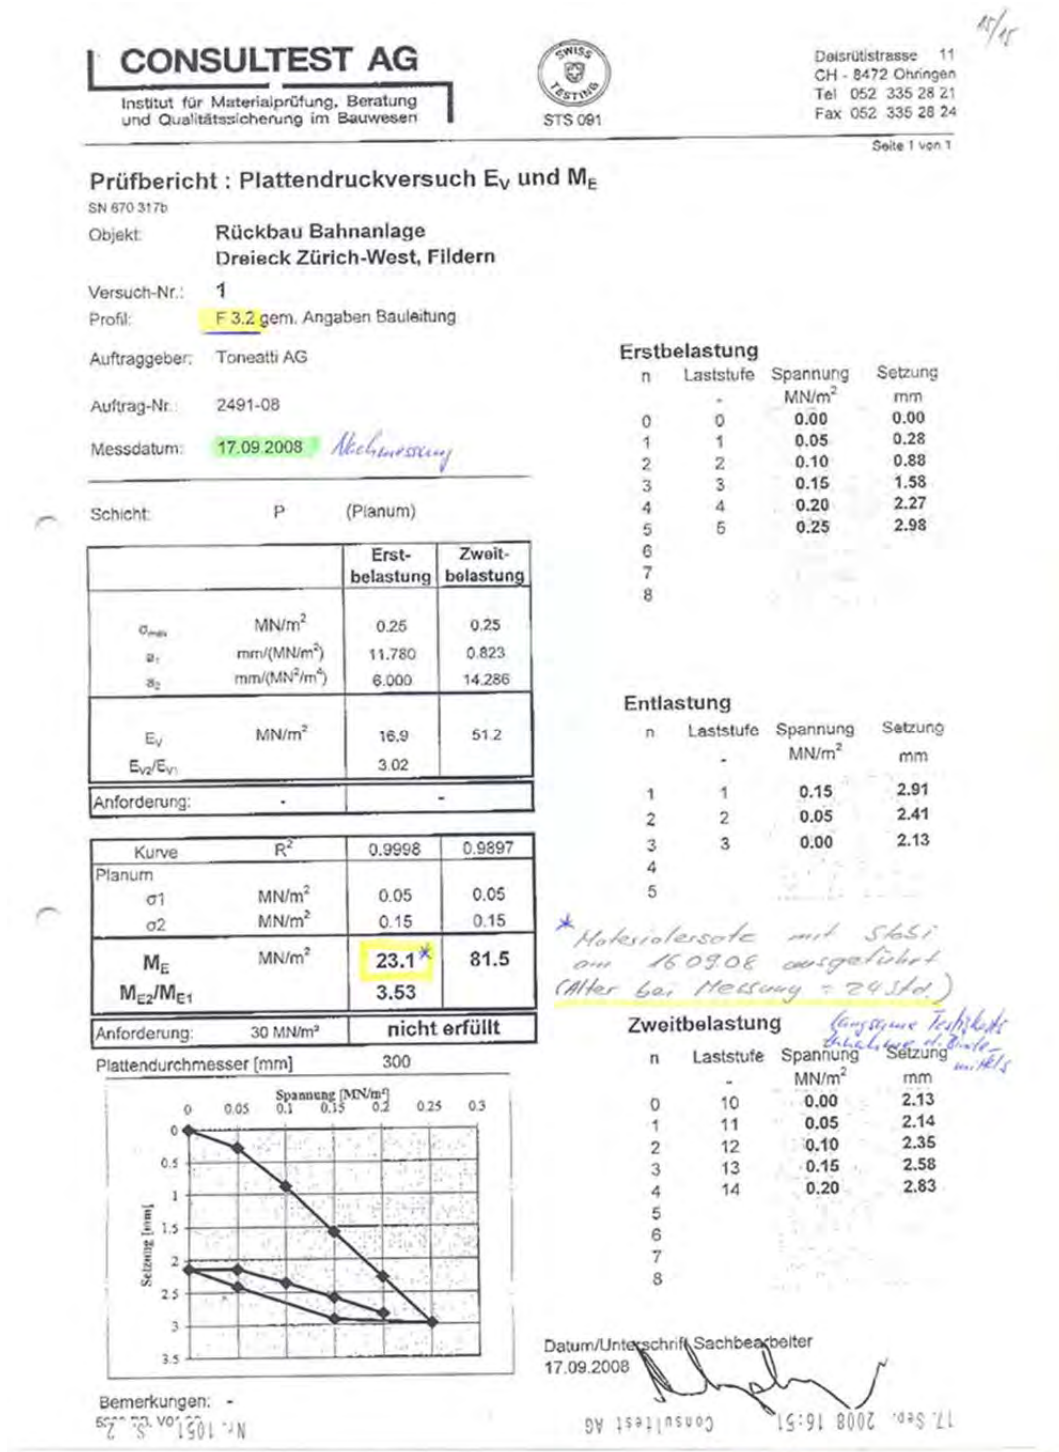
Fig. I.9 Static plate bearing test results Nr.3 of the subgrade in section F3.

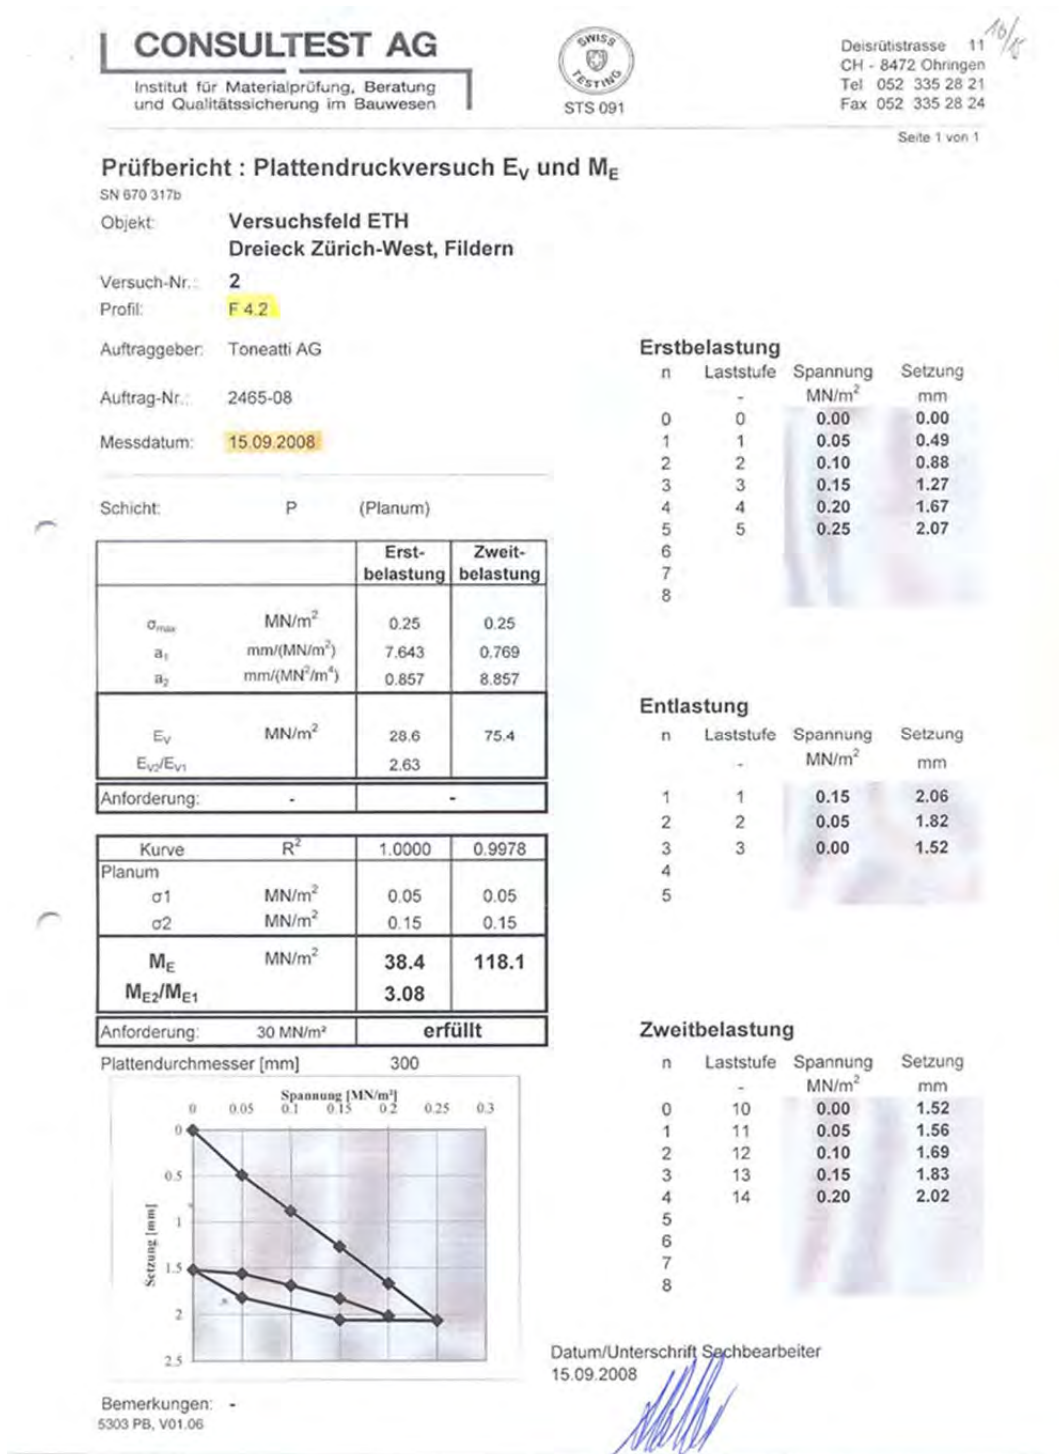
Fig. I.11 Static plate bearing test results Nr.2 of the subgrade in section F4.

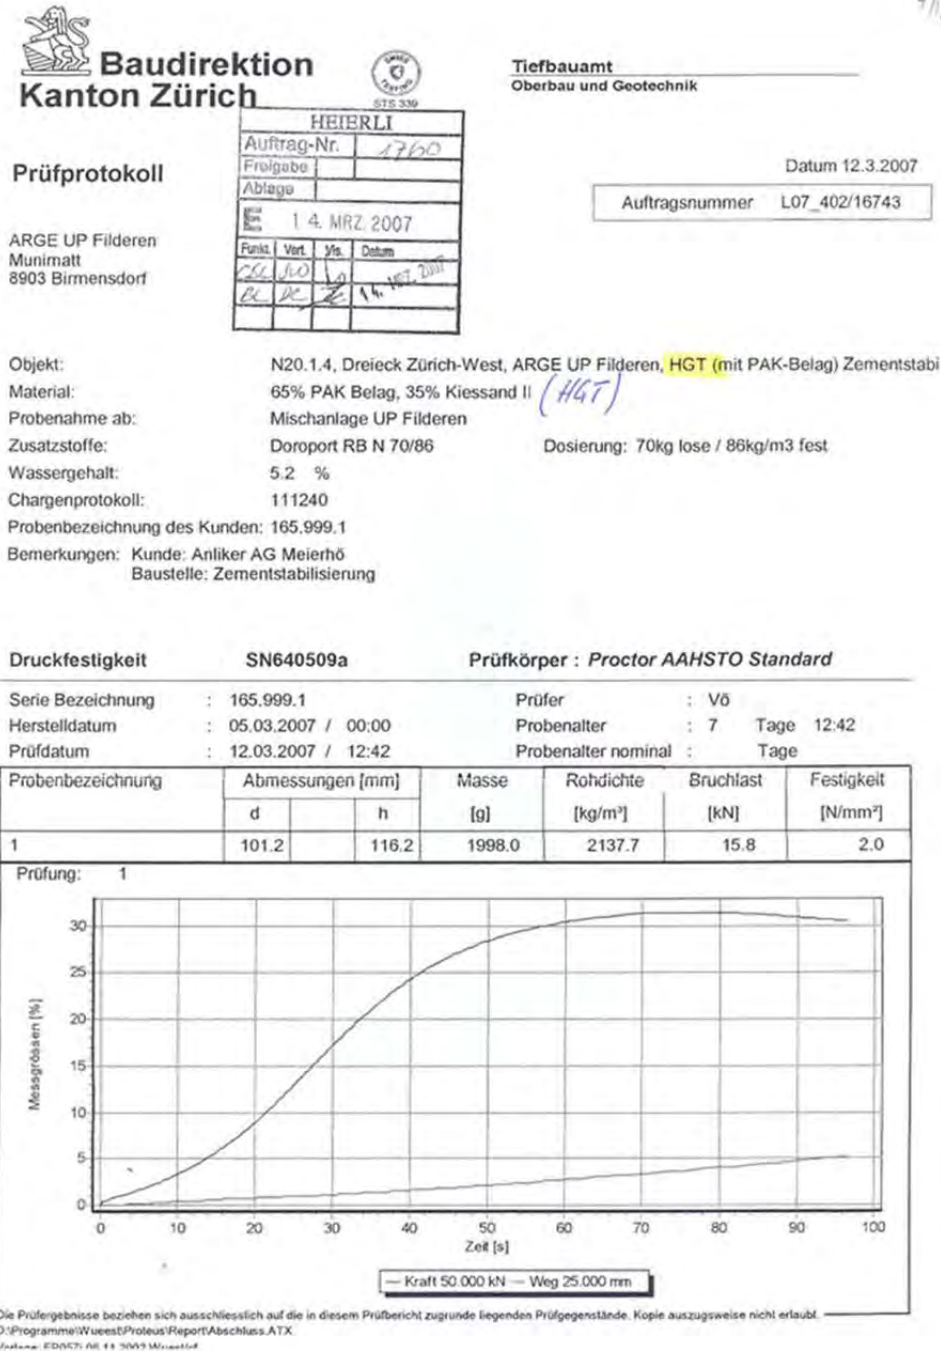
Fig. I.15 Compression tests of the cement stabilized material layer

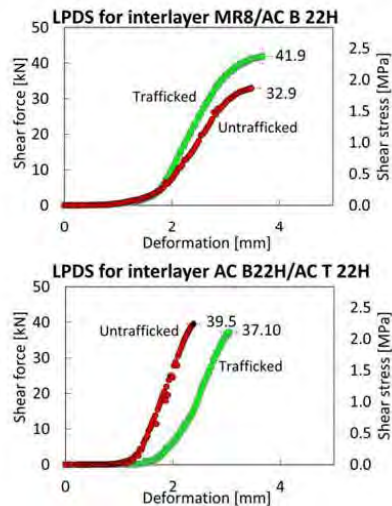
Figure 13. Comparison of the LPDS for both interlayers and loading condition.

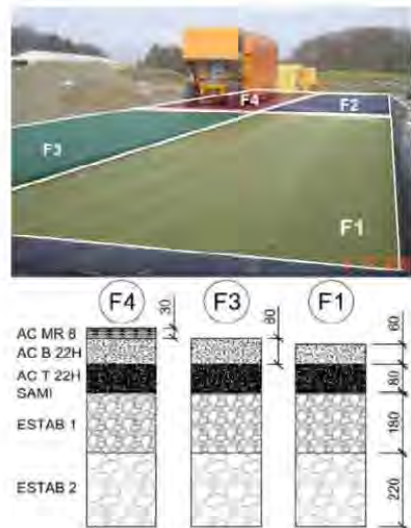
Figure 1. Layout of the sections and layers of the three pavements trafficked with the MLS10.

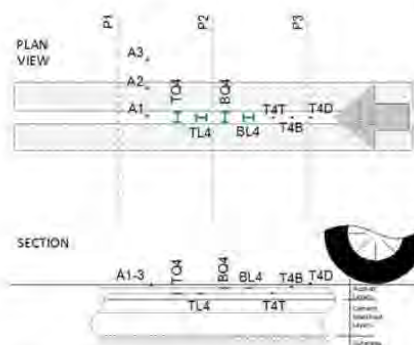
Figure 2. Schematic of the position of the sensors in Section F4.

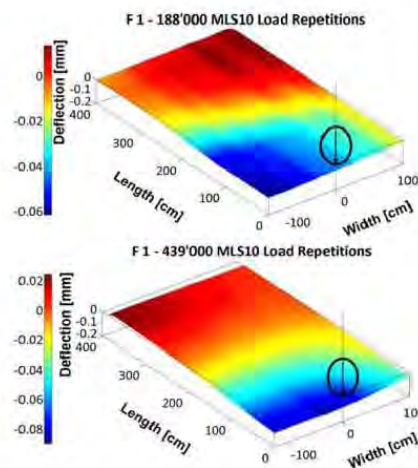
Figure 10. 3-D deflection measured with ETH Delta for two trafficking conditions on Section F1.

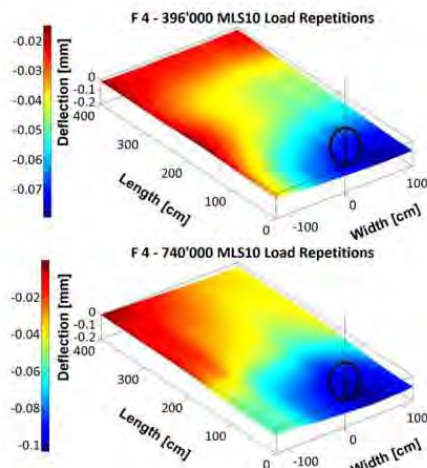
Figure 11. 3-D deflection measured with ETH Delta for two trafficking conditions on Section F4.

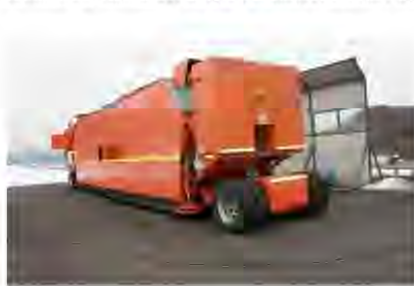
Trafficking was conducted under ambient conditions on each pavement structure with no temperature control. This was followed by a limited number of load applications on sections of each pavement structure under controlled temperature with traffic wander. The test site and equipment is shown in Figure 4 and test results are summarized in Table 3.

Figure 4. MLS66 on the RubAP/LAC test sections at Nanzanmu.

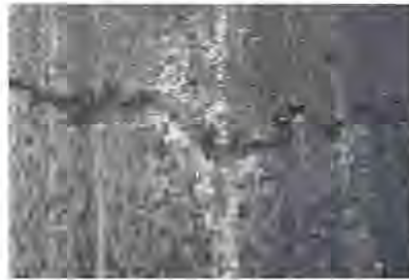
Figure 5. Close-up view of transverse crack on rubberized asphalt.

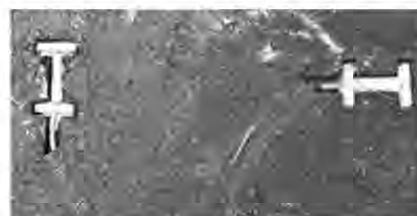
Figure 7. Strain gauges prior to asphalt covering.

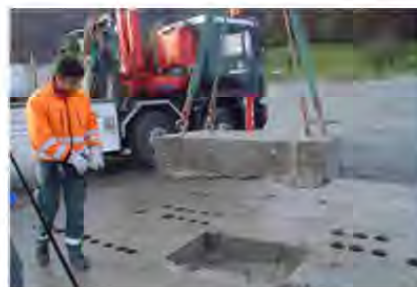
After completion of the tests a 190 mm asphalt slab was cut from Section F4 (Figure 8) of the full-scale pavement and transported to the laboratory for temperature conditioning and subsequent MMLS3 testing. A 10 mm interlayer of cement/sand mix was spread between the 190 mm asphalt block and an underlying 300 mm concrete block prior to seating the slab on it. The slab was instrumented to measure strains (Figure 9). The MMLS3 was then straddled over the asphalt block for trafficking (Figure 10).

Figure 8. Extraction of asphalt slab from test pavement.

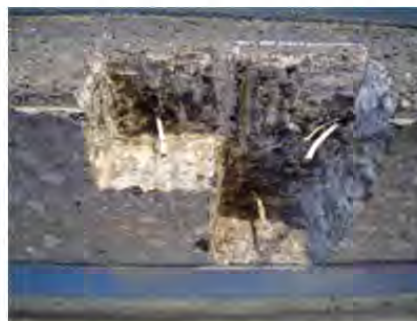
Figure 9. Cables for monitoring strains under lab trafficking.
