## **Praxis-Kalibrierung der neuen mobilen Grossversuchsanlage MLS10 für be- schleunigte Verkehrslastsimulation auf Strassenbelägen in der Schweiz**

**Performance-Calibration of the novel full-scale test ma-  
chine MLS10 for accelerated traffic simulation on Swiss  
roads**

**Empa, Eidgenössische Materialprüfungs- und Forschungsanstalt**  
**Martin Arraigada, Dr., dipl. Ing.**  
**Manfred N. Partl, Prof. Dr., dipl. Ing. ETH**  
**Hiroyuki Kato, dipl. Ing.**  
**Andrés Pugliesi, dipl. Ing.**  
**Andreas Treuholz, Msc.**

**Forschungsauftrag ASTRA 2007/011 und ASTRA 2010/005\_OBF auf  
Antrag des Bundesamtes für Strassen (ASTRA)**

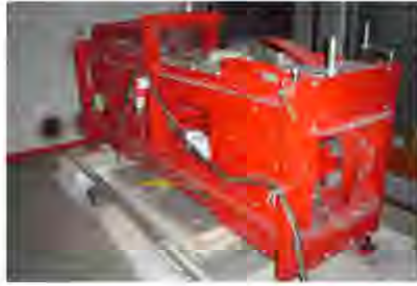
Figure 10. MMLS3 trafficking of extracted slab.

After completion of the tests a 190 mm asphalt slab was cut from Section F4 (Figure 8) of the full-scale pavement and transported to the laboratory for temperature conditioning and subsequent MMLS3 testing. A 10 mm interlayer of cement/sand mix was spread between the 190 mm asphalt block and an underlying 300 mm concrete block prior to seating the slab on it. The slab was instrumented to measure strains (Figure 9). The MMLS3 was then straddled over the asphalt block for trafficking (Figure 10).

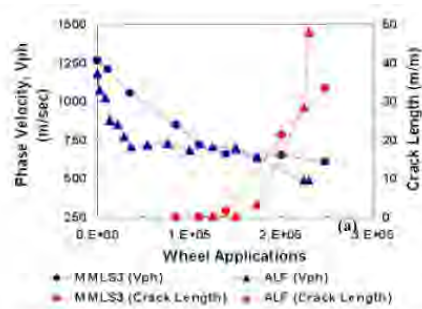
Figure 11. Phase velocity and cumulative surface crack length as a function of wheel applications (Lee, 2003).

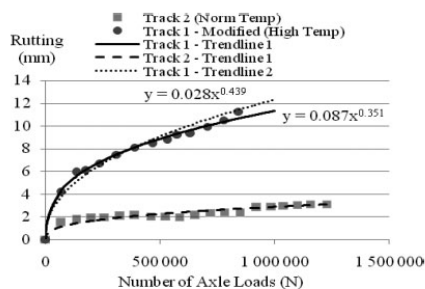
Figure 15. Averaged rutting performance based on extension of the trend line of the heated conditions to compensate for the deleted axle loads.

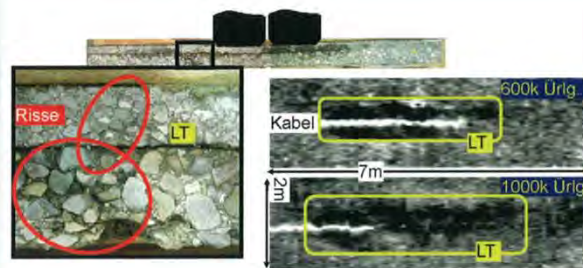
Bild 3: Lagentrennung (LT) und Risszone im entnommenen Riegel nach 1000k Überrollungen (links unten); GPR Landkarte in 4,5 cm Tiefe nach 600k und 1000k Überrollungen (rechts unten)

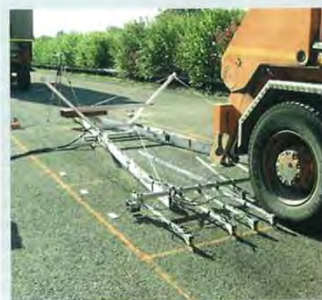
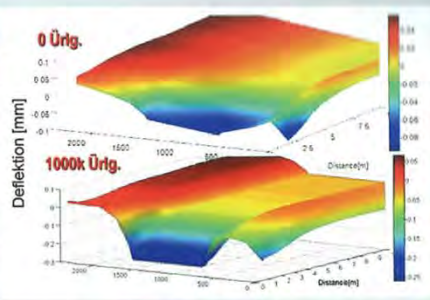
Bild 4: ETH-DELTA Gerät mit grosser Deflexionsmulde nach 0 und 1000k Überrollungen

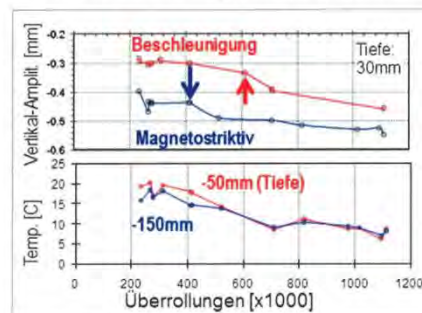
2: Amplituden der Vertikaldeflektionen beim Überrollen mit Beschleunigungssensoren und magnetostriktiver Relativmessung inklusive Belagstemperatur in verschiedenen Tiefen; die Pfeile bezeichnen den mutmasslichen Beginn massgeblicher Schädigung.
